This footrot sample collection kit instruction is a guide for the collection of samples for the isolation of *Dichelobacter nodosus* from footrot lesions.

### Sample Collection Kit

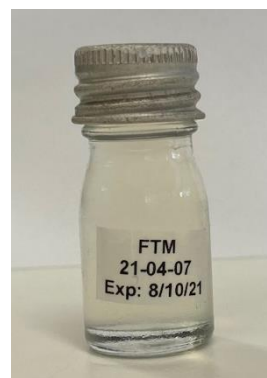
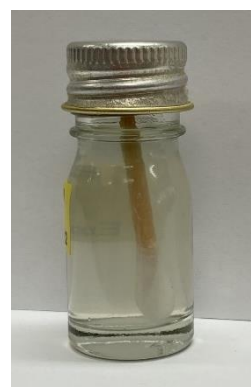
1. Check each bottle of transport media. The FTM should be opaque and colourless (Figure 1). **Do not use the bottle if the indicator in the medium has turned blue or if the bottle is not full.**
2. Using the cotton tipped sterile swab provided, collect sample material from the active area of a lesion.
3. Remove the lid and push the swab deep into the FTM, break the swab off level with lip of the bottle and replace the lid firmly to create an airtight seal. Use one swab per bottle of FTM (Figure 2).
4. Refer to the Foot Scoring Details table included in the Specimen Advice Form to label bottles to identify the animal sampled. Record the details on the lid and adhesive label on the bottle with a water-proof permanent marker.
5. Transport medium should be returned to EMAI as soon as possible and kept cool during transit.

**N.B.** Store unused media at 4°C. **The transport media will remain satisfactory providing the indicator in the medium has not turned blue and the bottle is full** and should be used before the expiry date on the bottle. Care is required with transport of unused transport media during hot weather. It is preferable to keep the media chilled. **Please return expired transport media to EMAI.**
