# **Kooragang Wetland Rehabilitation Project: History of Changes to Estuarine Wetlands of the Lower Hunter River**

June 2000  
NSW Fisheries Final Report Series  
No. 22  
ISSN 1440-3544

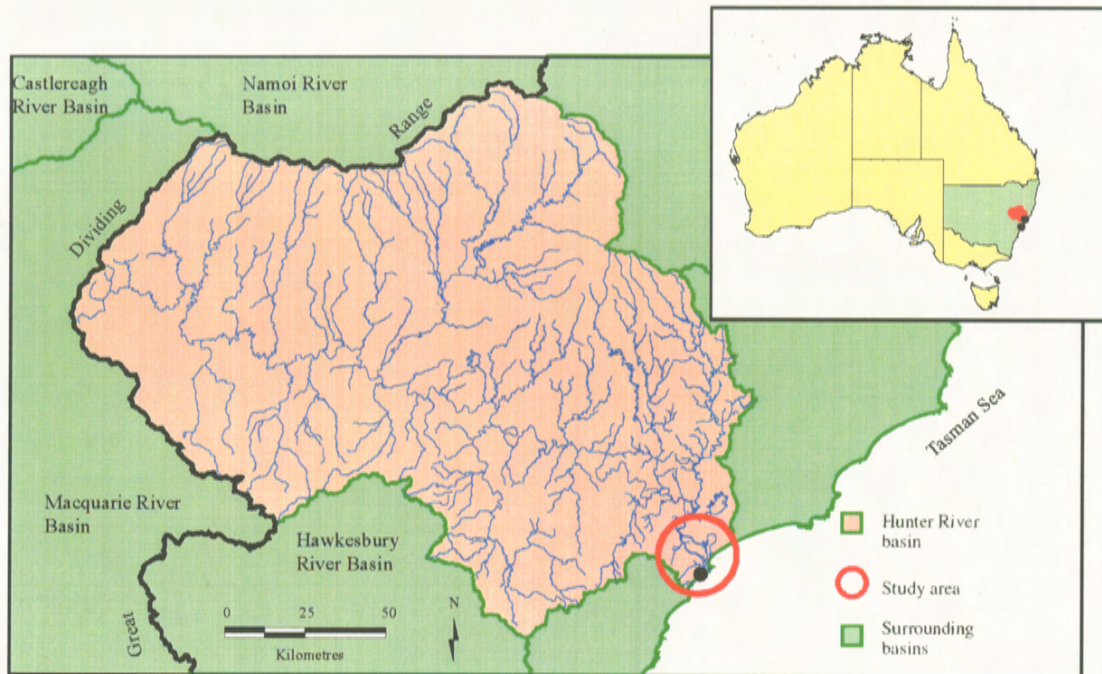
**Figure 2.1.** Hunter River and adjacent waterbasins. Modified from NSW Water Resources Commission (undated).

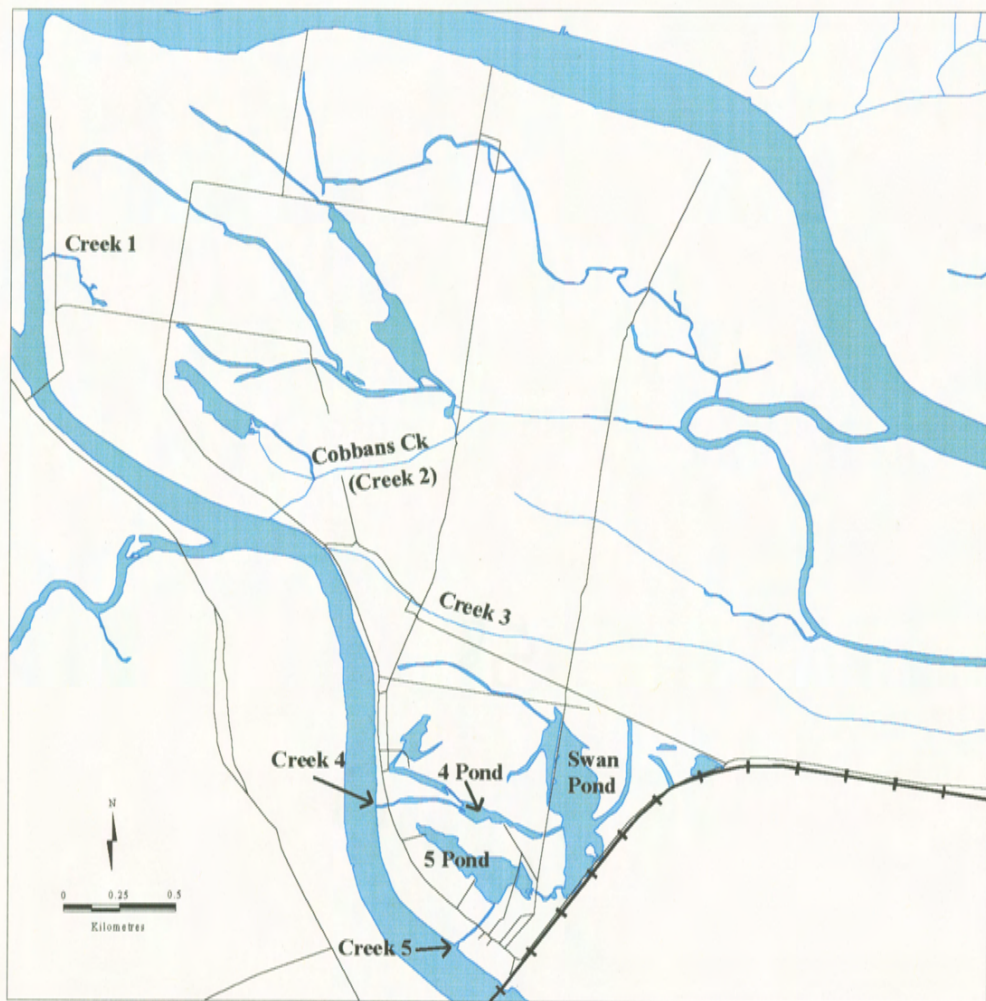
**Figure 3.10.** Creeks affected by changes in drainage patterns on western Kooragang Island.
