# Acid Sulfate Soil

## Assessments in the Anna Bay Catchment

REPORT TO THE HUNTER-CENTRAL RIVERS  
CATCHMENT MANAGEMENT AUTHORITY

November 2008

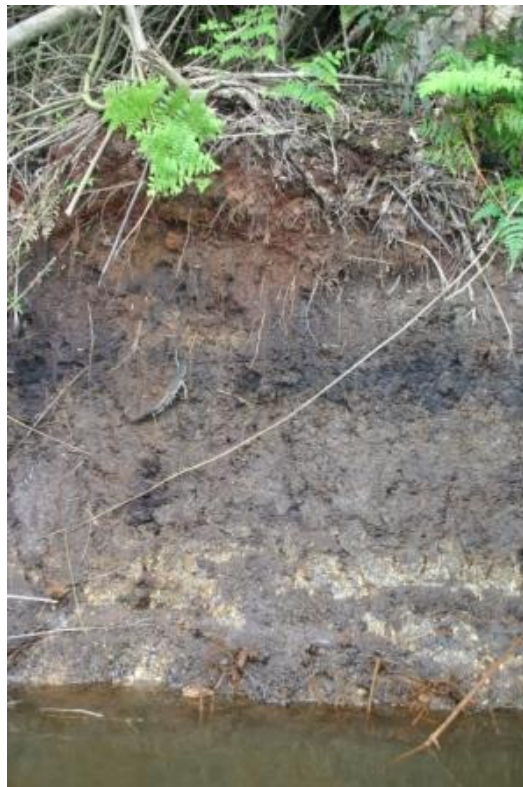
Pyrite (or jarosite) is stable under anoxic conditions (water-logged) but on exposure to air, the wet sulfidic soil horizon known as potential acid sulfate soils or PASS will oxidise, forming sulfuric acid (Sammut et al., 1996). Oxidised soil layers are characterised by yellow mottling (Fig 5) and are known as actual acid sulfate soils (AASS).

**Figure 5** *Yellow mottling of pyrite seen in the bank of the Main Drain, Anna Bay, above the drain water level. The dark band indicates evidence of previous peat fires (photo: S. Walsh)*

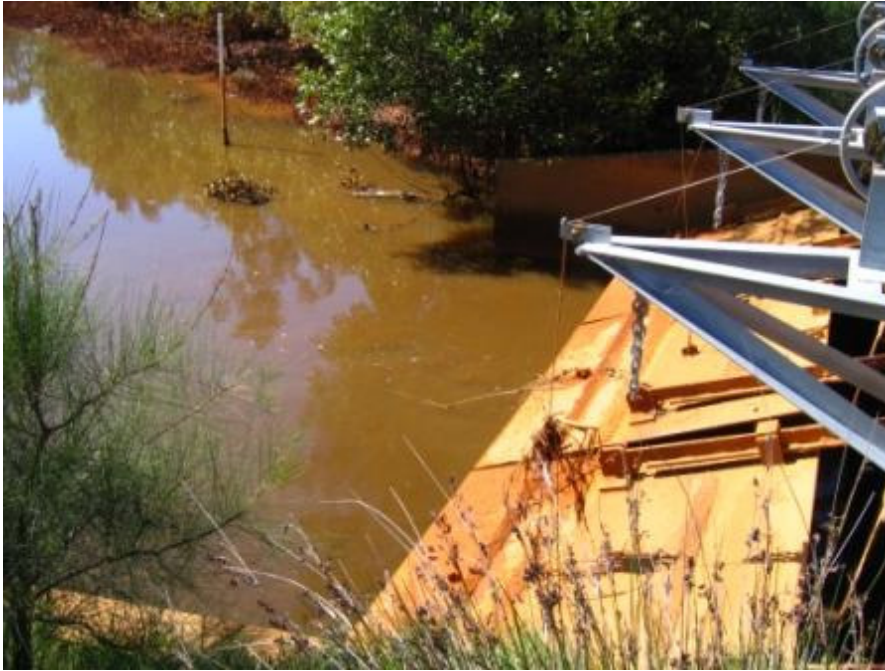
The acid in turn mobilises iron, aluminium and other metals present in the soil (Indraratna et al., 2005) which leaches into ground water and adjacent drains. Exported iron can oxidise again in waters that are considerable distances away from the source, producing iron oxyhydroxide or hydroxide flocs (iron floc) that coat benthic communities and stream banks (Fig 6) (Sammut et al., 1996).

**Figure 6**      *Wallis Creek floodgates and mangrove community coated in iron floc.*  
(photo: A. Burke)

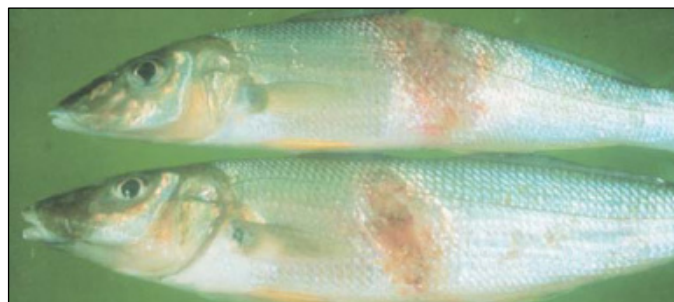
**Figure 7**      *Lesions from red spot disease in sand whiting (Source: D. Callinan)*

Impacts associated with ASS are most noticeable after rain events following a period of drier conditions. Extended dry periods cause the watertable to lower, further oxidising layers of potential ASS. Drought-breaking rains then flush significant quantities of sulfuric acid and toxic, heavy metals into waterways, resulting in massive fish kills (White *et al.* 1997), diseases such as epizootic ulcerative syndrome (red spot disease, see Fig 7), and reproduction, recruitment and growth problems for aquatic organisms (Sammut, 1996).

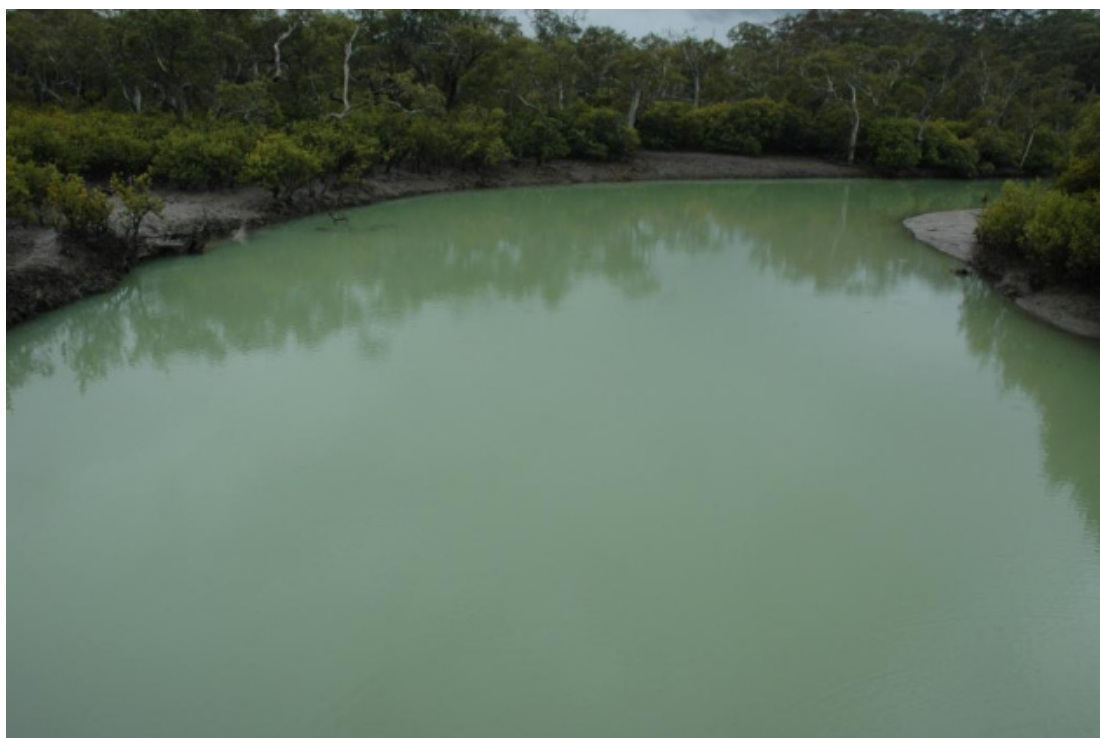
The results confirmed that acidification was occurring in the Wallis and Fenningham's Island Creek systems with aluminium and iron levels in the water alarmingly high. The milky green colour was caused by aluminium floccules suspended in the water column (aluminium concentrations in water samples taken were 60,400 µg/L at the floodgate and 5,760 µg/L 2.5km downstream in the estuary. Both of these figures exceed ANZECC guidelines. There was also extensive and substantial coating of iron oxyhydroxide floccules in the upper reaches of Wallis Creek below the floodgate and in the Main Drain (iron concentrations in water samples taken were 70,650 µg/L at the floodgate and 9,750 µg/L 2.5km downstream in the estuary (see Section 3.3.4 for ANZECC trigger values). The iron floccules observed in the water near the floodgate were mobilised into Tilligerry Creek and caused oyster shells to appear a red/orange colour (see Fig 9) and subsequently oyster growing operations were affected for an extended period.

*Figure 8 Wallis Creek waters milky green with aluminium floc (Photo: M. Dove). Water in this creek is generally dark brown.*

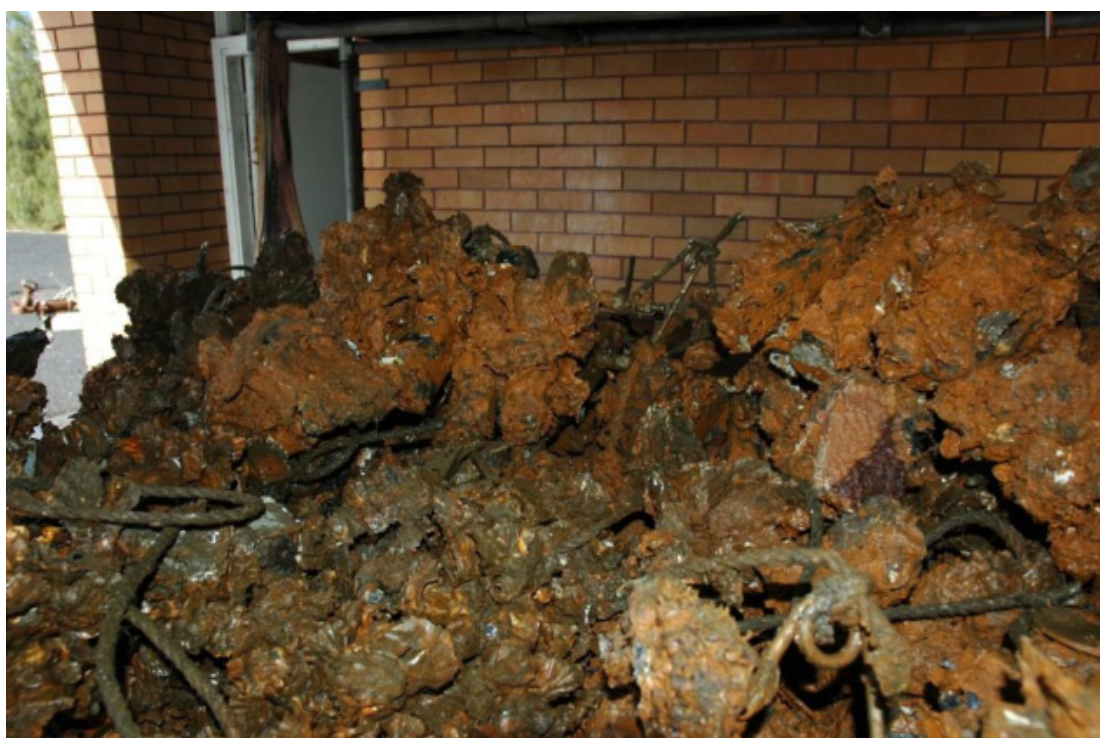
*Figure 9 Oysters removed from Fenninghams Island Creek coated in iron oxyhydroxide floccules discharged from the Main Drain (Photo: B. Perkins).*

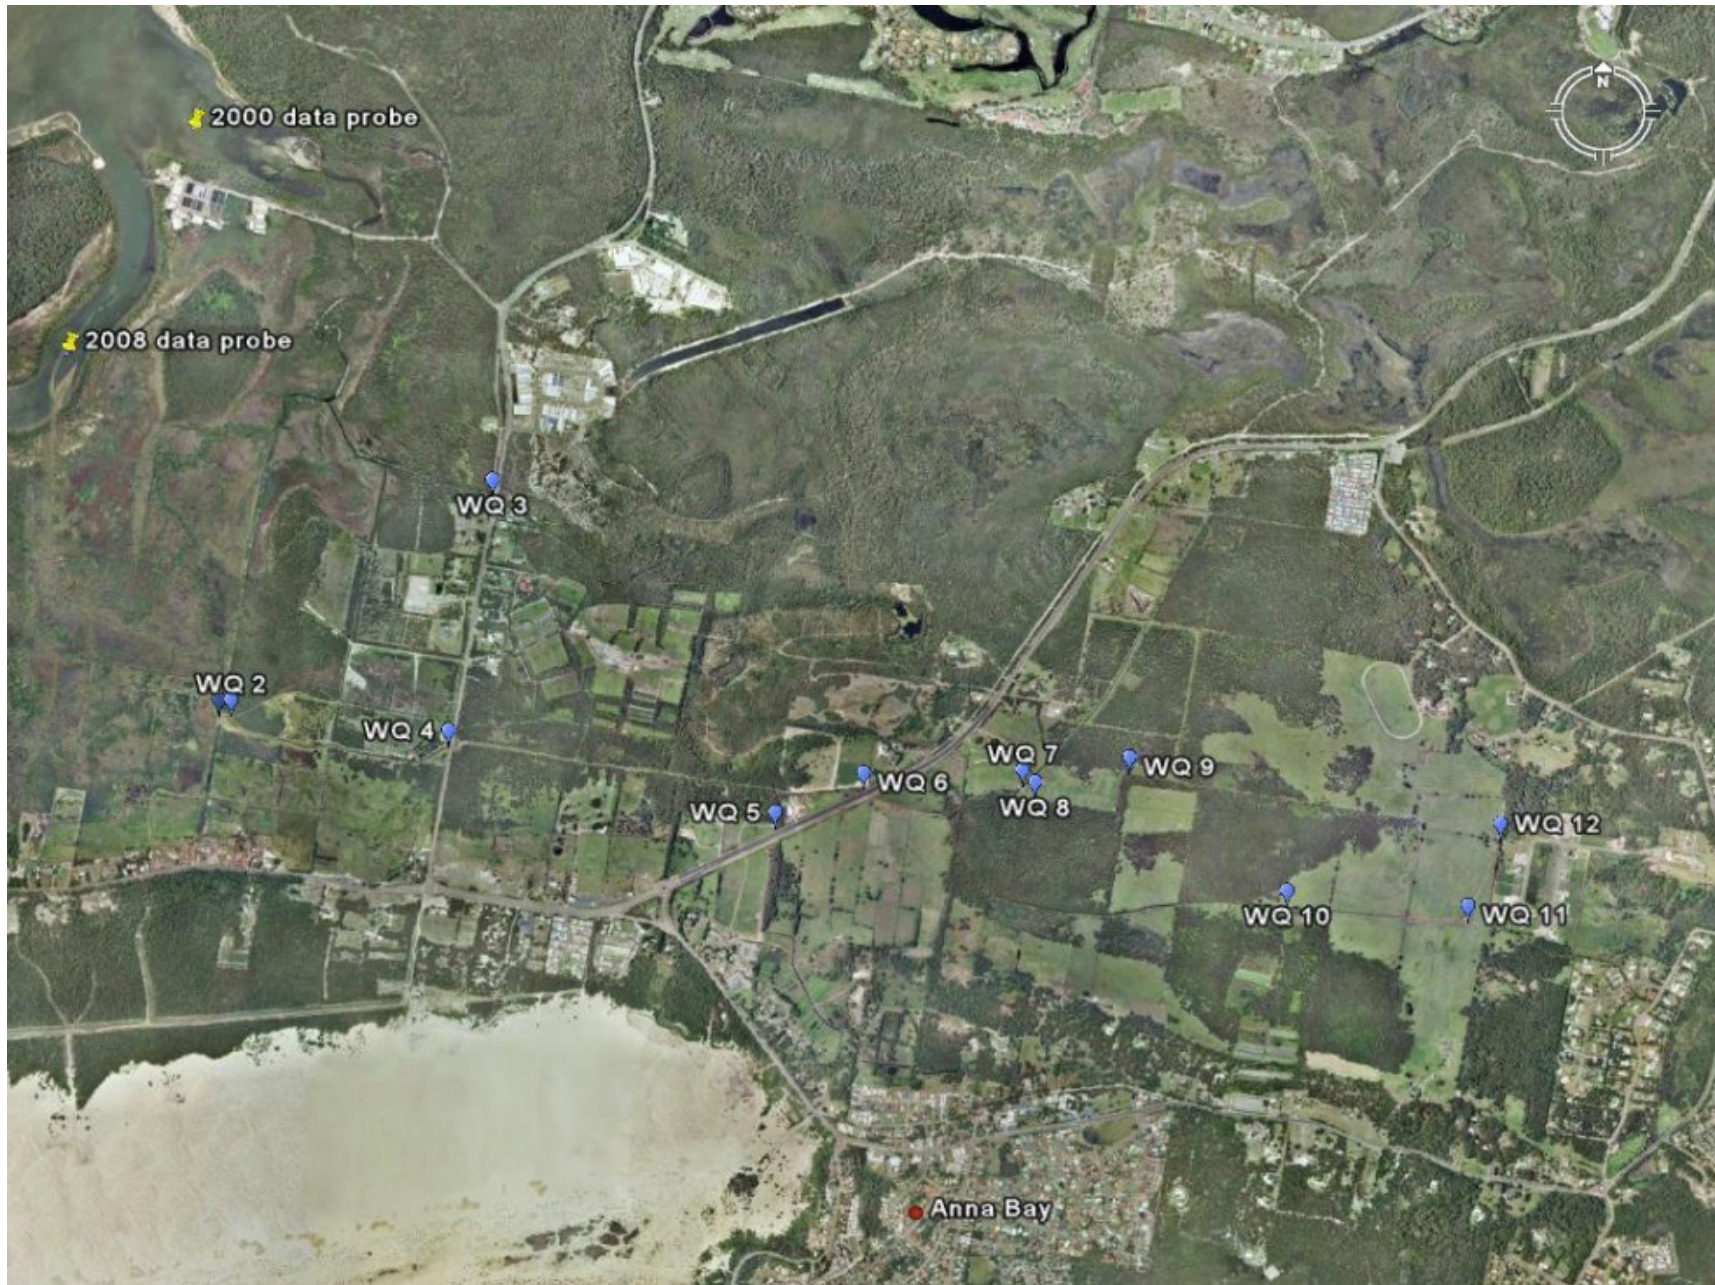
Figure 11 Water quality monitoring sites in the Anna Bay catchment (Imagery: Google Earth)

Water quality monitoring using a Horiba U-10 multi-parameter probe (pH, electrical conductivity, dissolved oxygen, temperature and salinity) was conducted in situ at low tide on a weekly basis at 12 locations throughout the Anna Bay drainage system (on the Main, Boron, and Ferntree drains and two unnamed side drains. See Fig 11 for locations).

In addition, an Insitu Troll 9500 data probe was installed in Fenninghams Island Creek to gauge pH and EC as a result of drain discharge. The probe took measurements every 20 minutes while deployed. This was deployed from 28<sup>th</sup> September 2007 to 9<sup>th</sup> April 2008 (Fig 11).

Environmental & Earth Sciences (2000a) previously installed a datalogger which measured EC and pH near Fenningham's Island (Fig 11).

The *Troll 9500* data probe was installed in Fenninghams Island Creek (Fig. 11) to gauge pH and conductivity as a result of drain discharge. The results are shown in Appendix 2 and rainfall for the same period is shown in Appendix 3 for comparison.

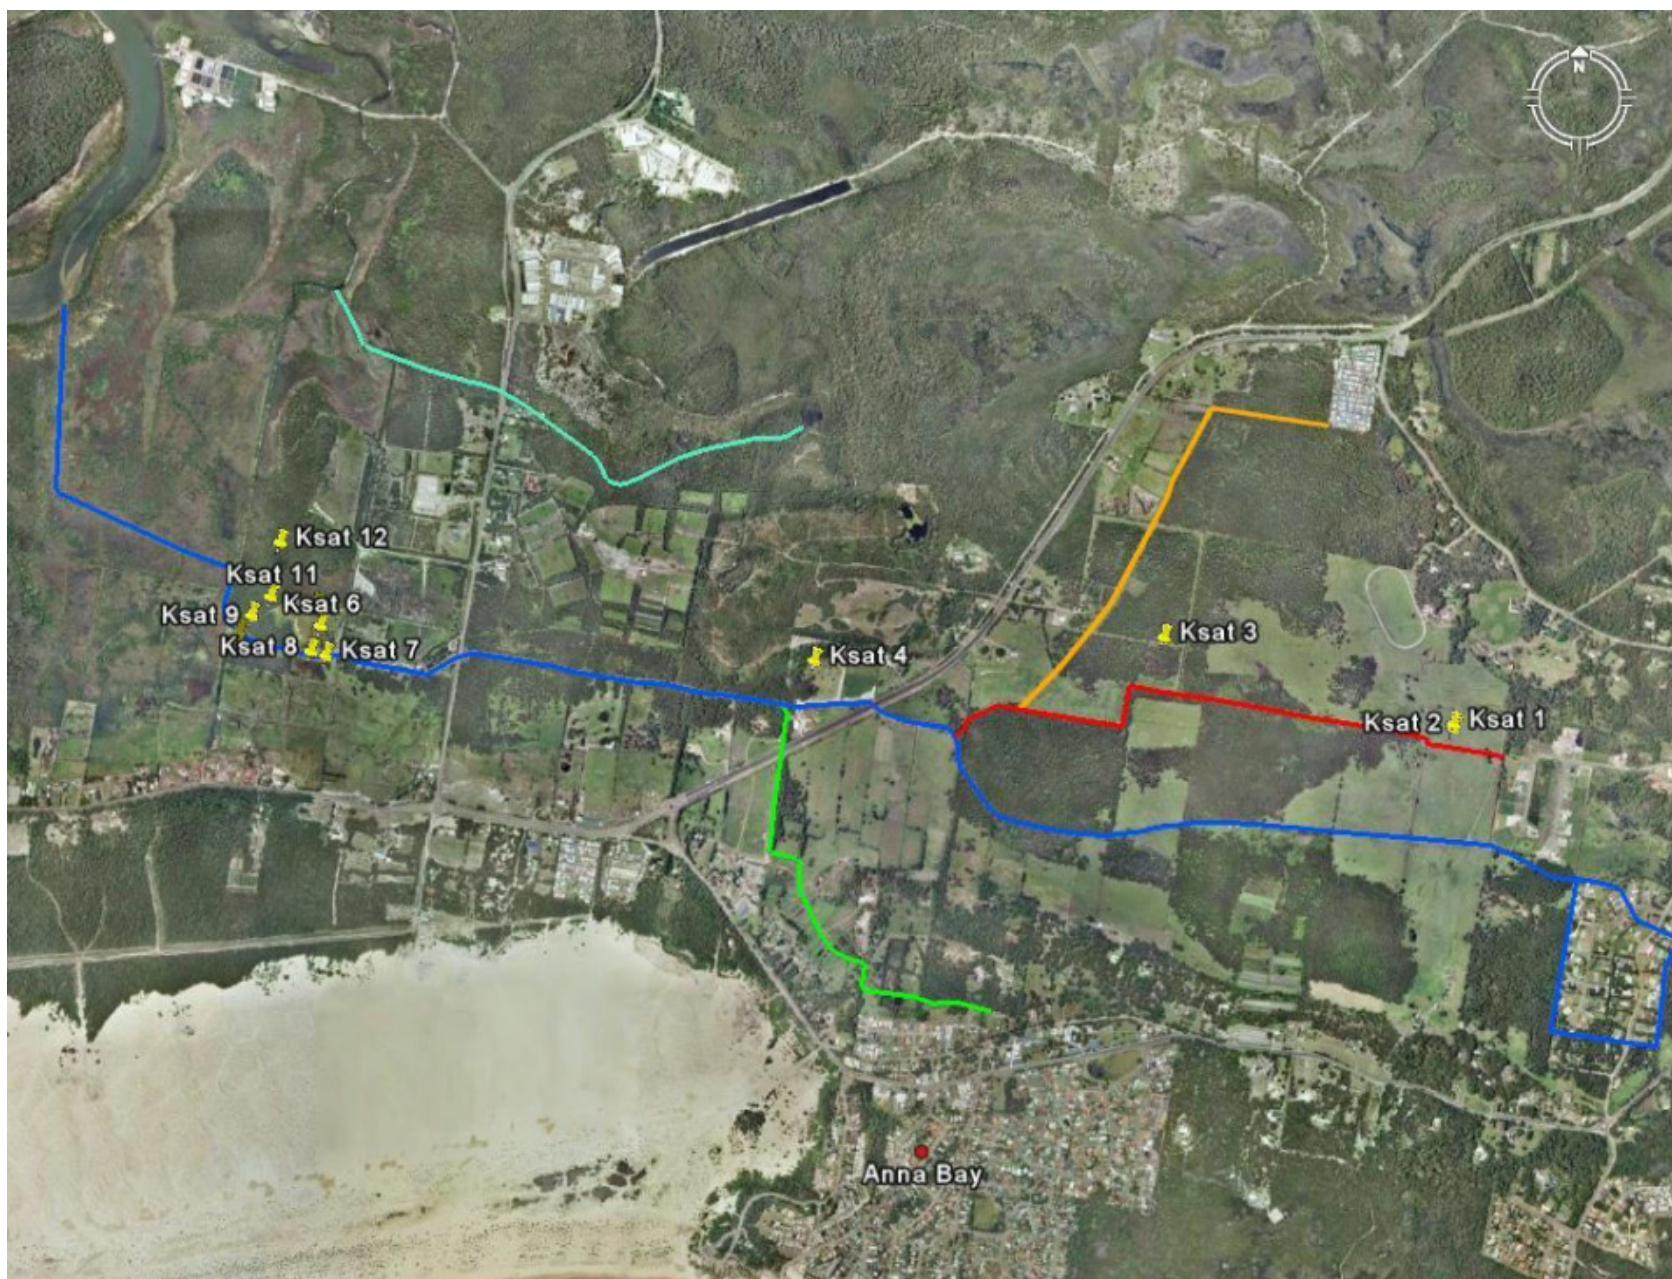
Figure 14 Hydraulic conductivity ( $K_{sat}$ ) pit location map (NB Ksat 11 is adjacent to Ksat 9) (Imagery: Google earth).

Saturated hydraulic conductivity ( $K_{sat}$ ) of the soil was assessed at 11 points along the Main and Back drains using the method for  $K_{sat}$  pit tests as described by S.G. Johnston & P.G. Slavich (2003) (see Fig 14 for pit locations).

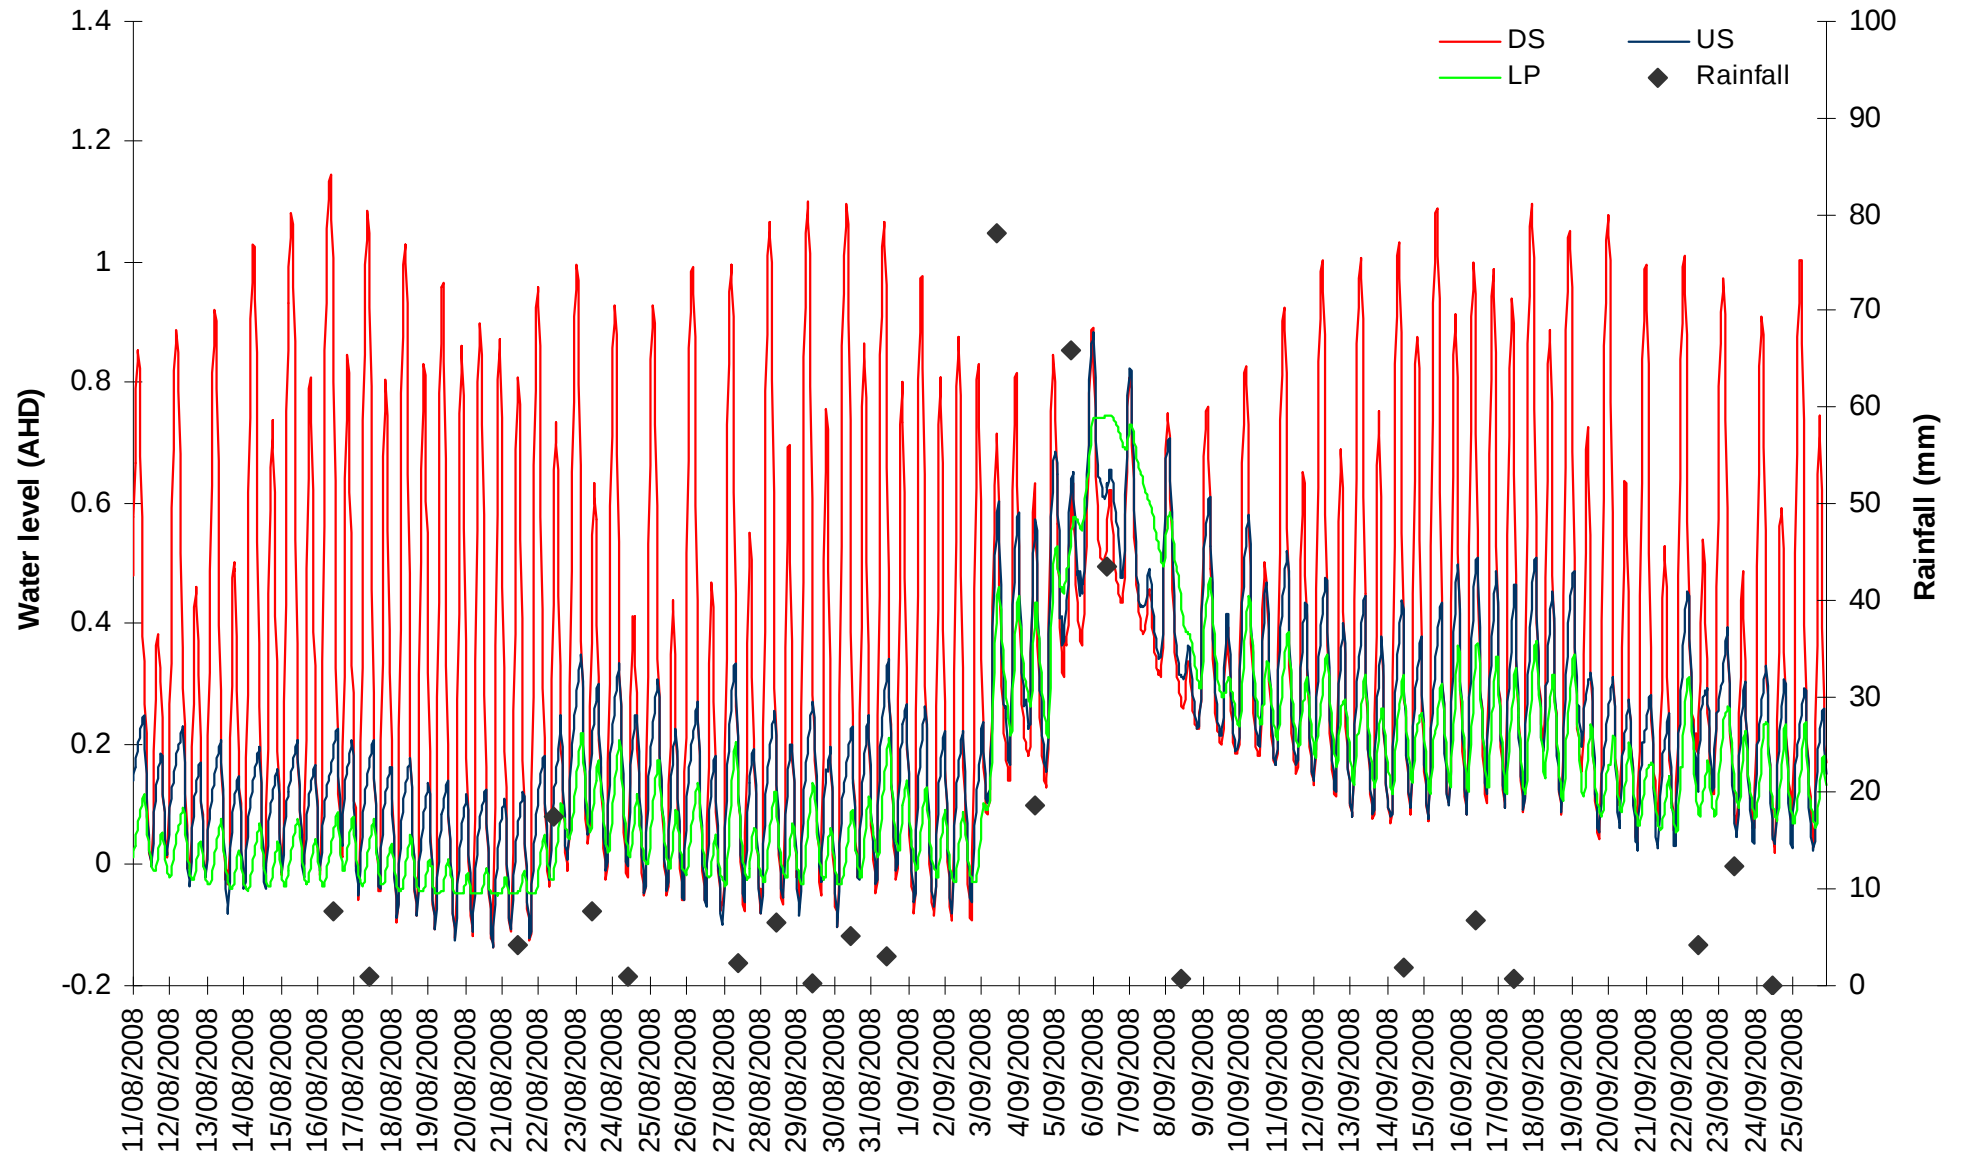
Figure 23 Comparative water levels (AHD) and rainfall (mm) at Anna Bay over 6 weeks (rainfall source: [www.weatherzone.com](http://www.weatherzone.com)).

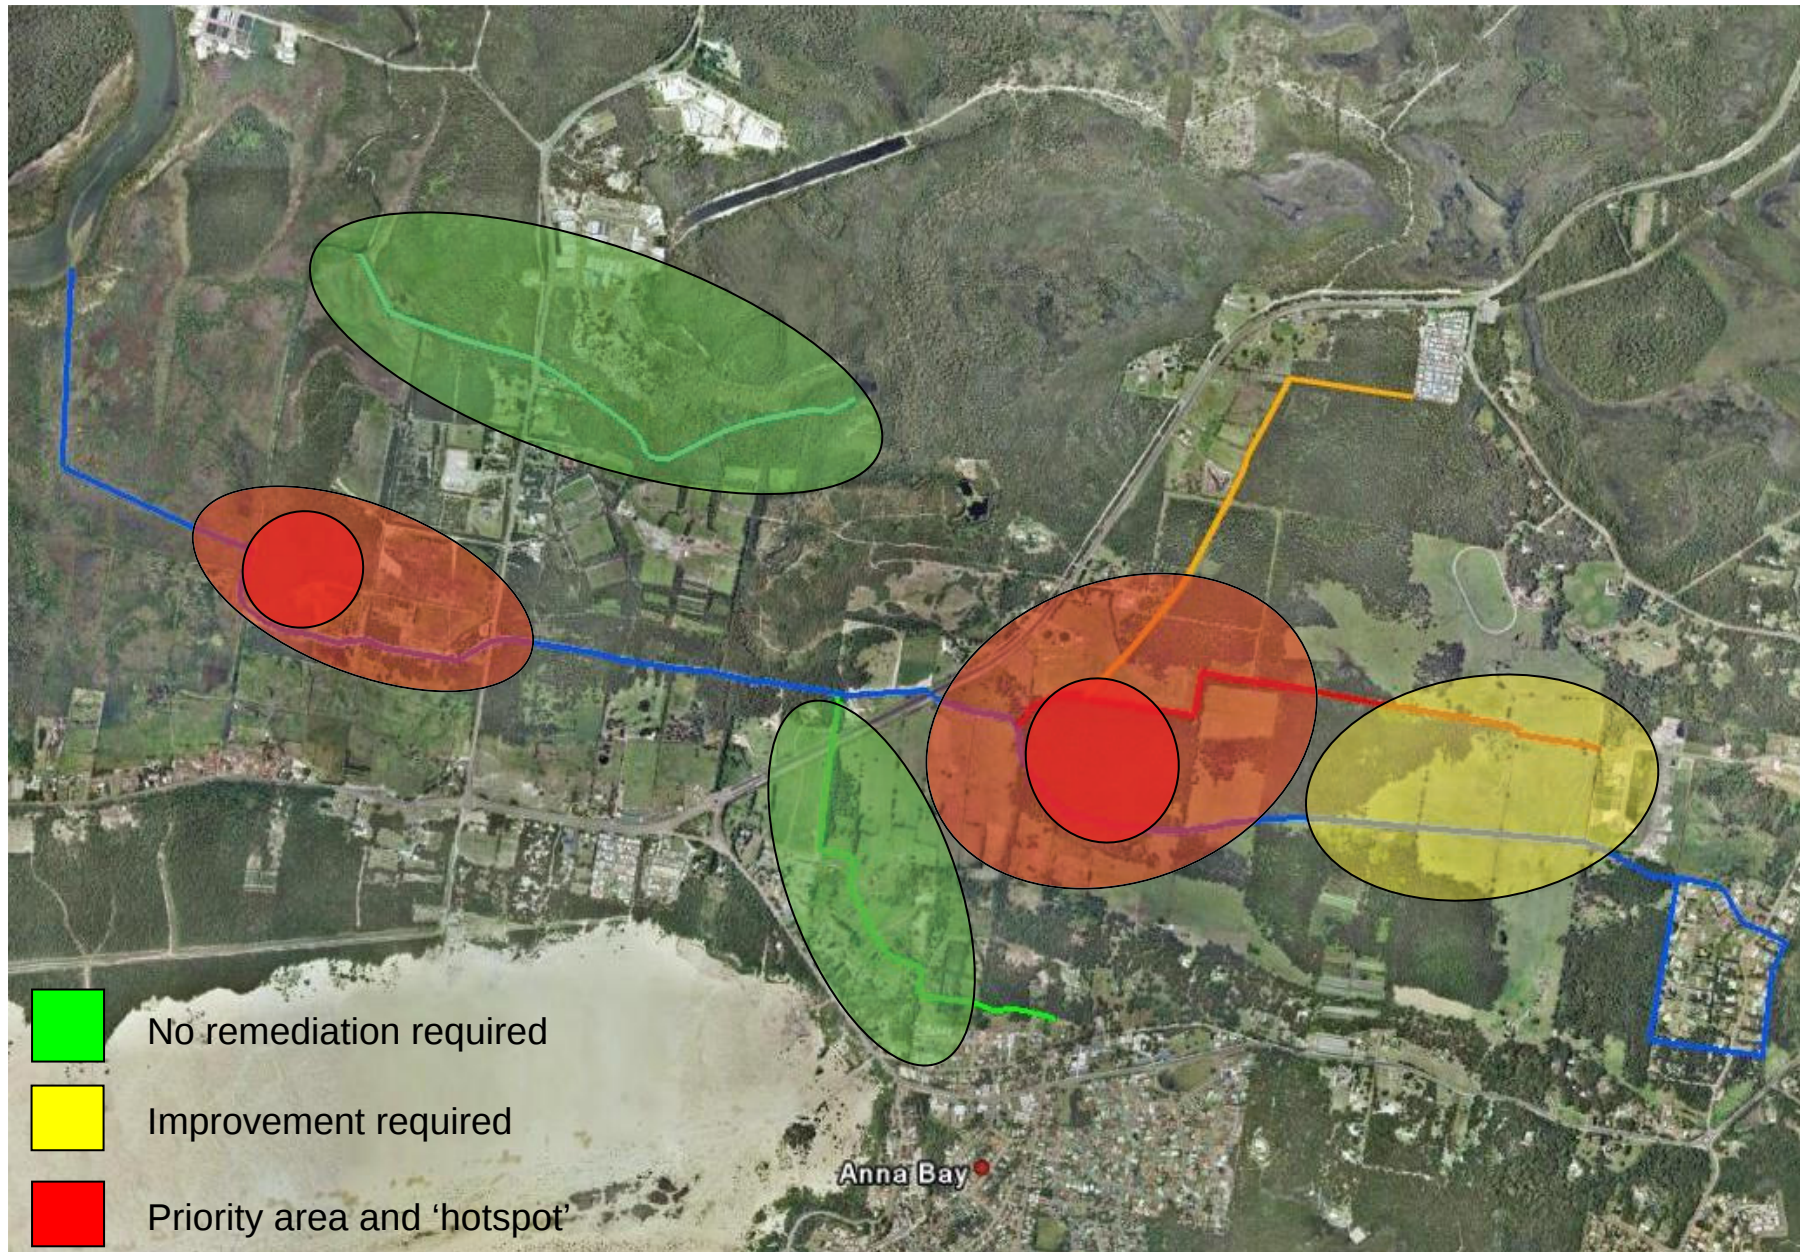
The eastern-most hot spot encompasses the area to the immediate east of Nelson Bay Road, and particularly the mature paperbark forest in-between the Main and Back drains. Water quality results are consistently poor in this area. Elevation information shows this area to be particularly low. The mature paperbark swamp is more than likely leading to significant drawdown of the groundwater, especially during extended droughts. Any reduction in groundwater levels would see a significant deterioration in water quality at this location. Management of this hot-spot would involve ensuring that groundwater levels were maintained above the local sulfidic horizon.

Figure 28 Risk map identifying priority areas for remediation works and areas where improvement is required.

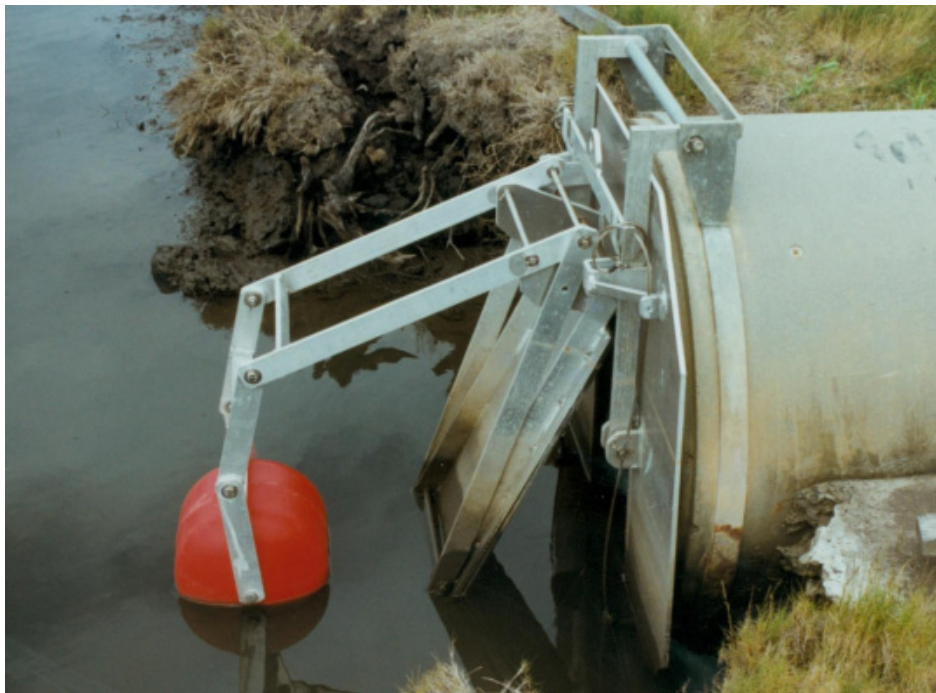
*Figure 31 Tidal floodgate which opens and closes as downstream water levels lower and raise the float.*

At the bottom of the catchment there is currently a 3-cell winch floodgate maintained by the Union. The Union has proposed a 6-cell floodgate system made of reinforced aluminium to improve flood mitigation. Installation of this structure will occur simultaneously with the water control structure on the provision that a minimum of 1 cell will be fitted with an auto-tidal gate (Fig 31).

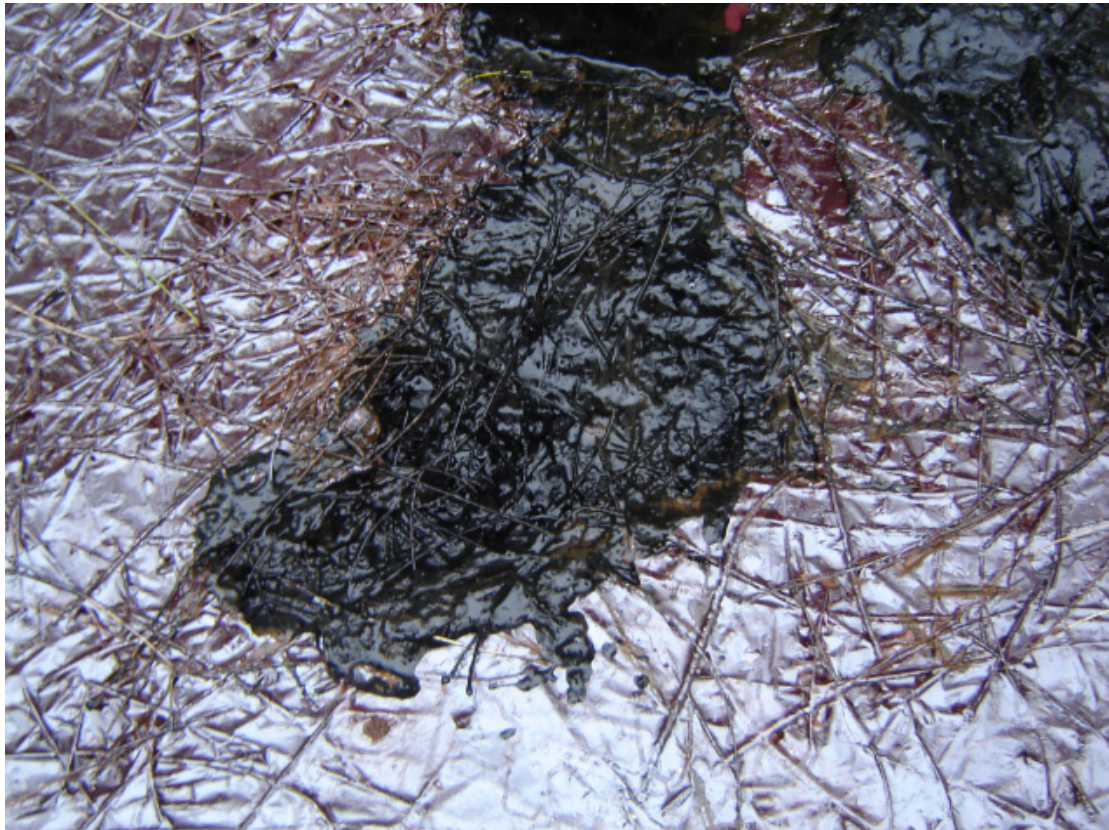
The rehabilitation of the *Casuarina* swamp, located near the Anna Bay floodgates, is essential as the water quality entering the Wallis Creek estuary off this site is of very poor quality. Inspections of the site found MBO just below the surface (Fig 32) and high levels of aluminium, iron and other heavy metals.

Figure 32 Monosulfidic black ooze at Site 2 in the *Casuarina* forest floor (Photo: A.Burke).

There are two rehabilitation actions recommended for this site:

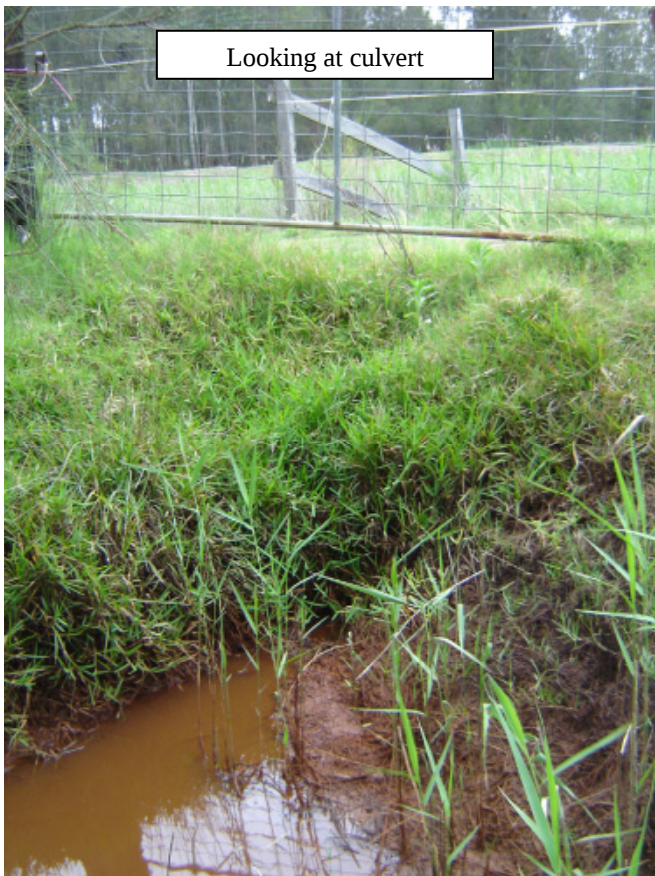
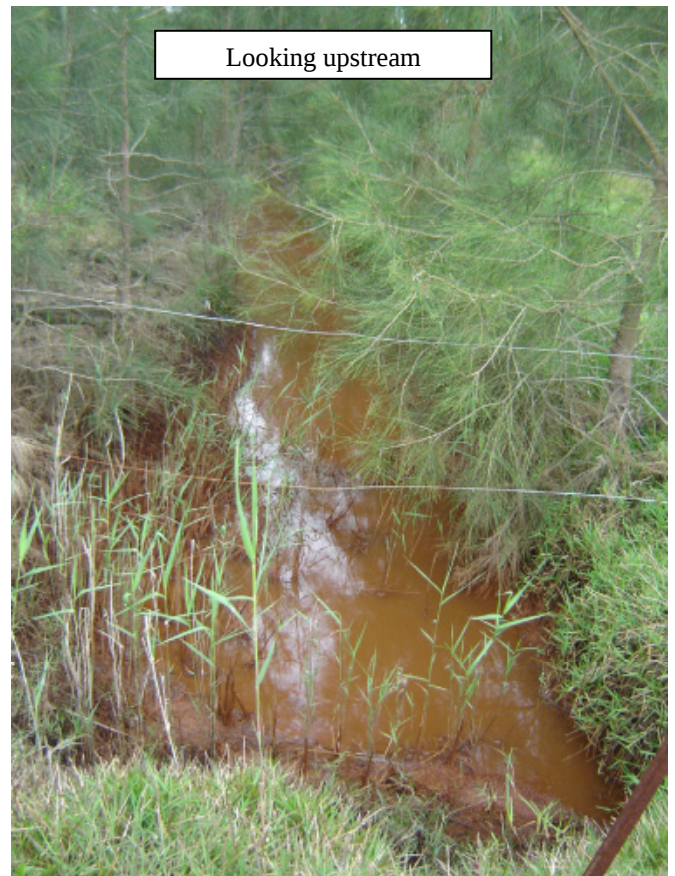
Images showing drainage system upstream of the floodgates.
