# Acid Sulfate Soils

Further investigations into the  
Lower Hunter River Estuary:

Woodberry, Irrawang and West Hexham Swamps

December 2010

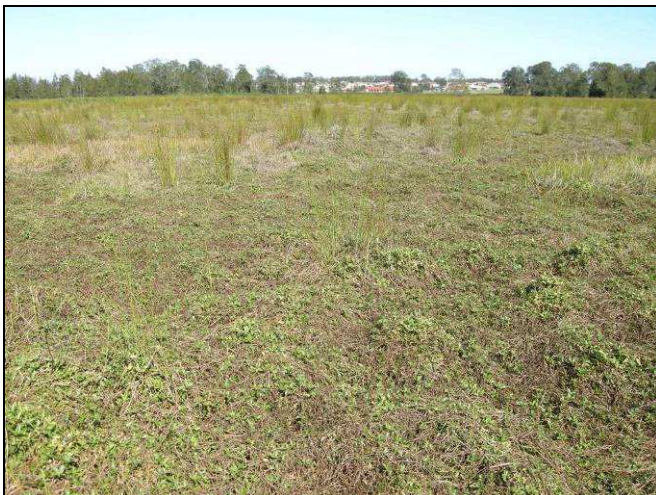
Figure 2: Alligator weed infestation in Swamp.

As is typical of most wetlands in this area, much of the native vegetation has been removed to create grazing paddocks, nevertheless stands of wetland reeds and rushes (cumbungi, juncus and phragmites) exist in wetter areas. Portions of the wetland are infested with introduced alligator weed and water hyacinth (figure 2). Past modifications to the drainage of the wetland have resulted in a relatively stable water regime (Winning *et al*, 2000), as constructed drains intersect the floodplain assisting drainage to Greenways Creek (figure 3). The presence of a floodgate at the entrance of Greenways Creek prevents tidal and flood inflows from the Hunter River.

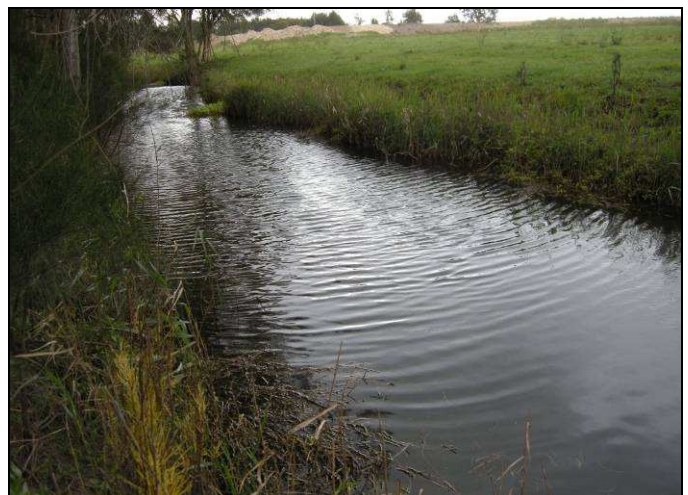
Figure 3: Greenways Creek drains the Swamp.

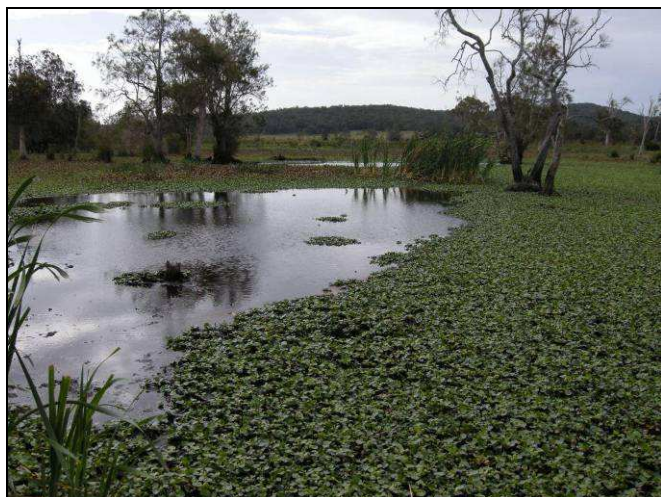
Figure 4: Surface water ponds in Irrawang Swamp

effectively grassland or pasture, while in prevailing wet weather it becomes waterlogged or flooded (figure 4) and can support a variety of wetland plants and animals.

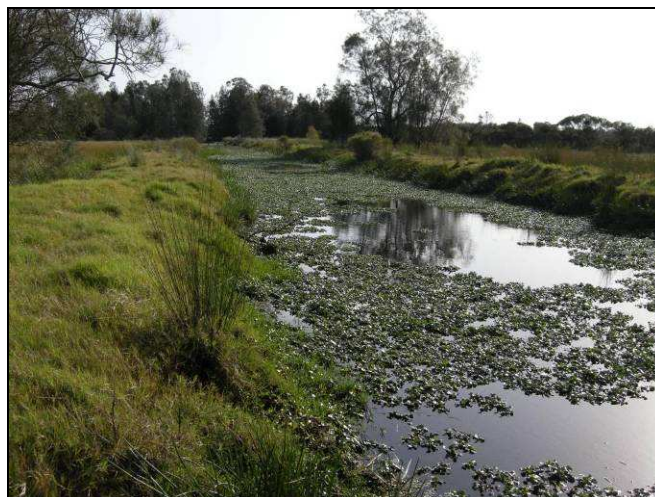
Figure 5: Pennington Drain channels surface flows

Hunter Water Corporation owns all low lying land in the Swamp, purchased for the Grahamstown Dam augmentation. The Grahamstown Dam Spillway discharges into the swamp when the Dam overflows. Constructed drainage channels, including the main Pennington Drain (figure 5) which bisects the swamp, carry water from the spillway to the Hunter River. There are several secondary drainage channels (evident in the Digital Elevation Model in Appendix A).

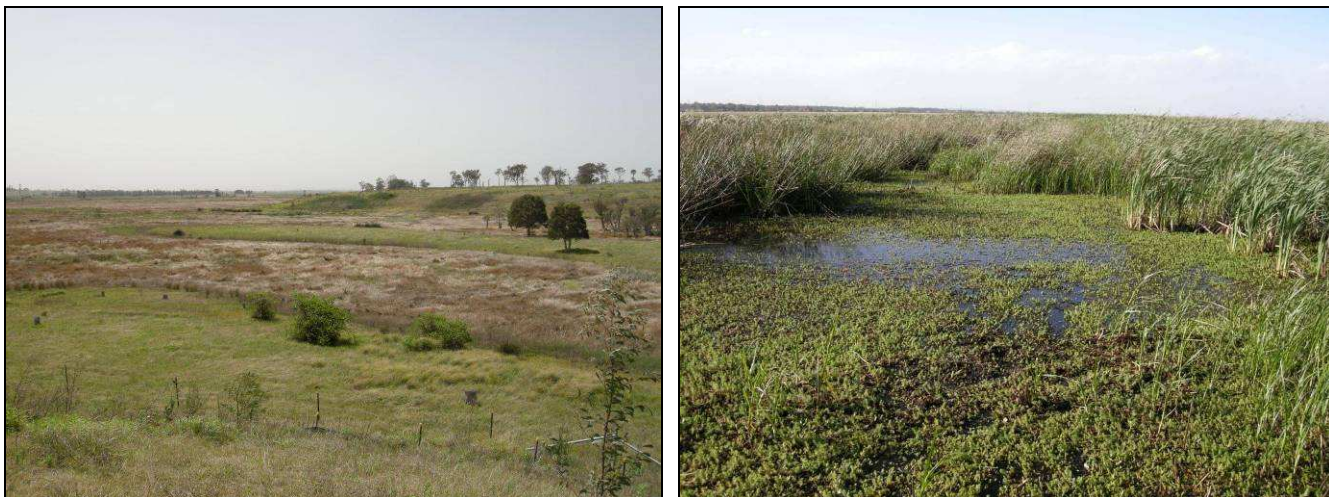
Figure 6: A valley draining to Hexham Swamp at Fletcher. Figure 7: Reeds are prolific in the centre of the swamp.

The previous ASS study (DPI, 2008) focused on the eastern portion of the swamp, extending from the northern corner near the disused rail line, along the Chichester pipeline and to Fishery Creek in the south. The western portion of the swamp was not previously assessed due to difficulties accessing waterlogged areas. Sites studied this round include the valleys on the western margins and into the interior of Hexham Swamp, accessed via the suburbs of Maryland, Minmi, Fletcher and Lenaghan (figures 6 and 7). Further description of Hexham Swamp is provided in DPI (2008).

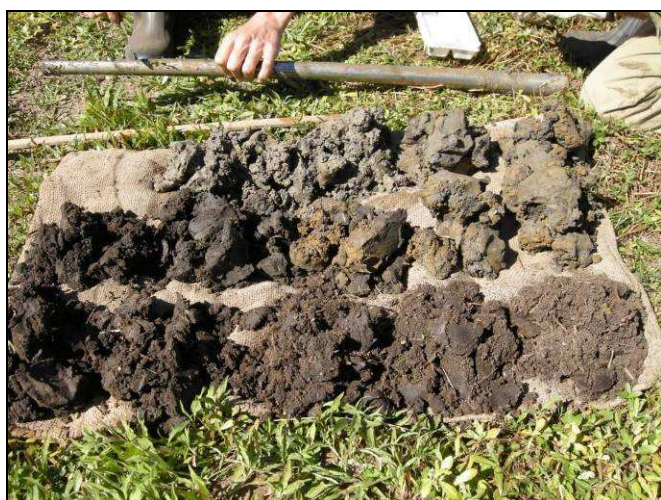
Figure 8: typical soil profile at Woodberry

The six soil profiles inspected across Woodberry Swamp (see figure 14) had similar major features. The topsoil is generally a dark crumbly clay, moderately to strongly aggregated, with a moderate tendency to form cracks when very dry (figure 8). The topsoil organic matter content is elevated (up to 6% organic carbon), with a peaty surface layer in places (figure 9). Closer to the Hunter River at Greenways Creek the dark clay is covered by a silty young alluvial deposit. Rusty mottles are common below the surface, indicating periodic waterlogging, produced by the perching of a watertable above or sometimes within the underlying dense clay subsoil. The clay is grey, with varying amounts of yellowish brown mottling and has a low porosity and hydraulic conductivity. Graphs of soil chemical properties are provided in Appendix C.

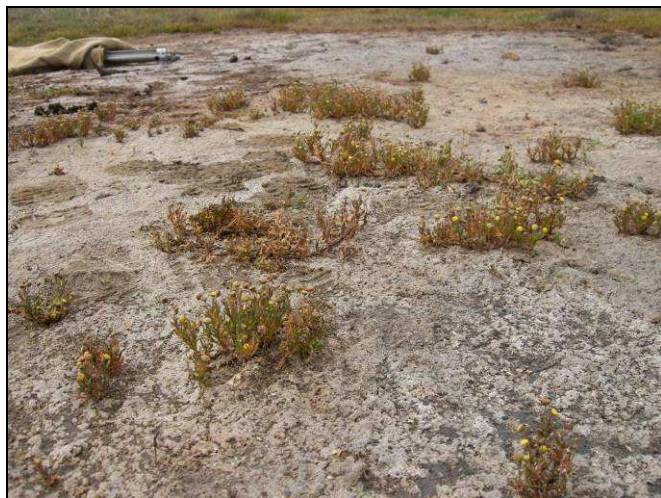
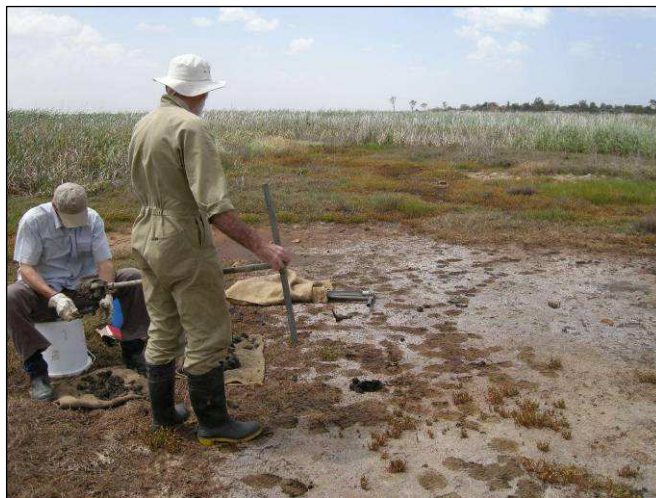
Away from Greenways Creek patches of bare ground exist, a few with a salty surface crust (see figures 10 and 11). The crust is produced in dry conditions by evaporation from a shallow saline water table. These patches seem to be more common in the elevated parts of the swamp, especially in the long south west arm between Thornton and Beresfield. The surface water is fresher in the lower parts of the catchment to the east, possibly because runoff (including urban stormwater) is more concentrated here. This helps to leach salt out of the upper part of the soil. This is reflected in the vegetation of the eastern part, which has

Figures 10 and 11: Woodberry (W2) core site, exhibiting saline scalds on the soil surface.

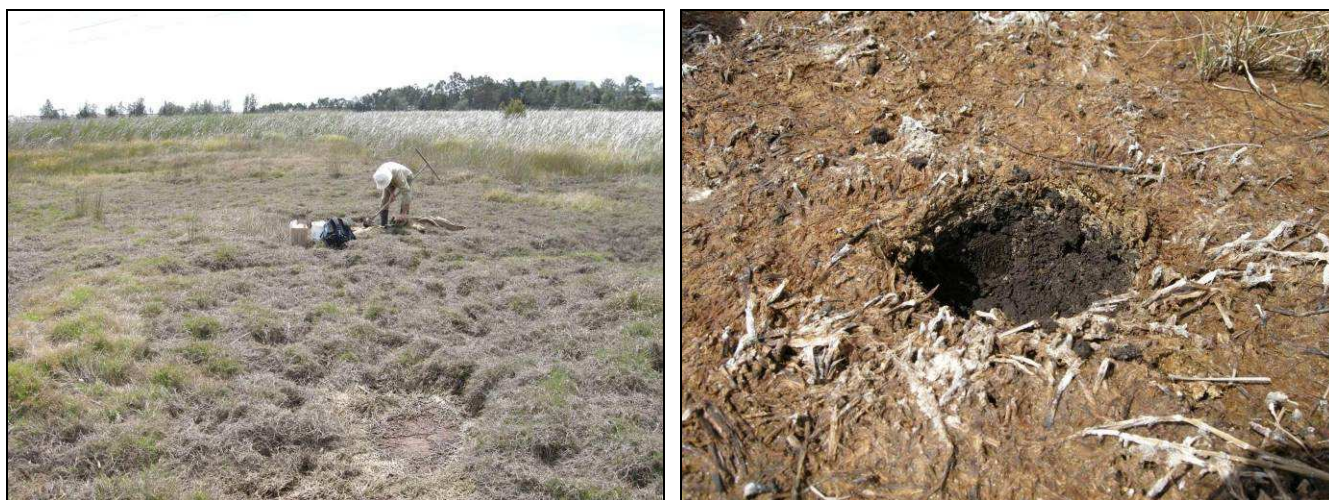
At the bottom of water filled depressions across the swamp, sulfides can accumulate as a result of microbial breakdown of dead plant residues. When the soils are waterlogged their high sulfate content is susceptible to reduction back to sulfide. When the pools dry out these black deposits oxidise, turning brown on the top and generating acidic run off (as seen near sites W1 and W6). Below the black layer of decayed plant residues the wet soil can become slightly sulfidic and when it starts to dry, a bright yellow ASS mineral called jarosite can form within the top few millimetres of the soil (figure 13).

Figures 12 and 13: Site W6 where there are small surface scalds and thick jarosite deposits on the surface.

Surface acidity is the main risk at Woodberry Swamp, and in some areas (including the far south west corner of the swamp near the New England Highway at site W6) the topsoil has already been acidified by oxidation of surface sulfides during dry conditions. Surface sulfide minerals that form at the soil surface under water are oxidised to sulfuric acid when dry, which can then be washed off the surface into adjacent waterbodies following the next rainfall event.

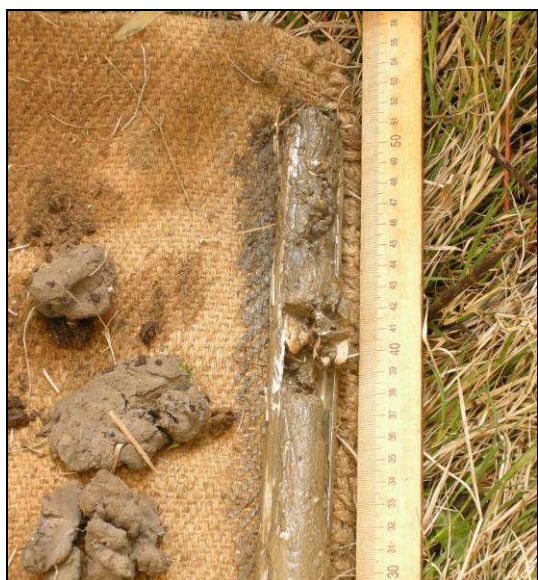
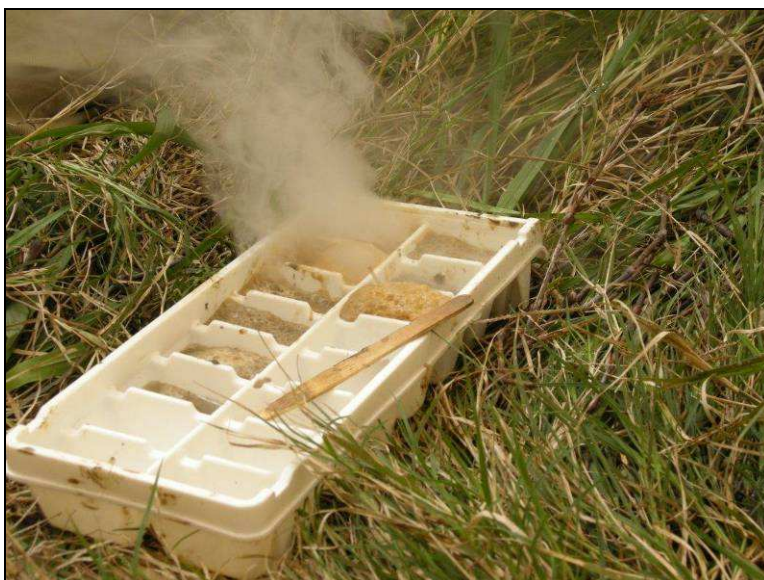
Below the water table the subsoil becomes very soft and there is a grey sulfidic layer containing shells (figure 15), and traces of jarosite are present just above it. This layer, which reacted vigorously with a peroxide test (figure 16), lies well below sea level (its upper boundary is -0.8m Australian Height Datum (AHD) at site I6 and -1.4 m AHD at site I7) and contains much more sulfide than the topsoil (0.74% at site I6 and up to 1.0% at site I7), see table 5 and 6.

Figure 15: Site I6 has shells in profile at 167cm. Figure 16: A soil reaction with peroxide at site I6 (190cm depth) indicates the presence of PASS.

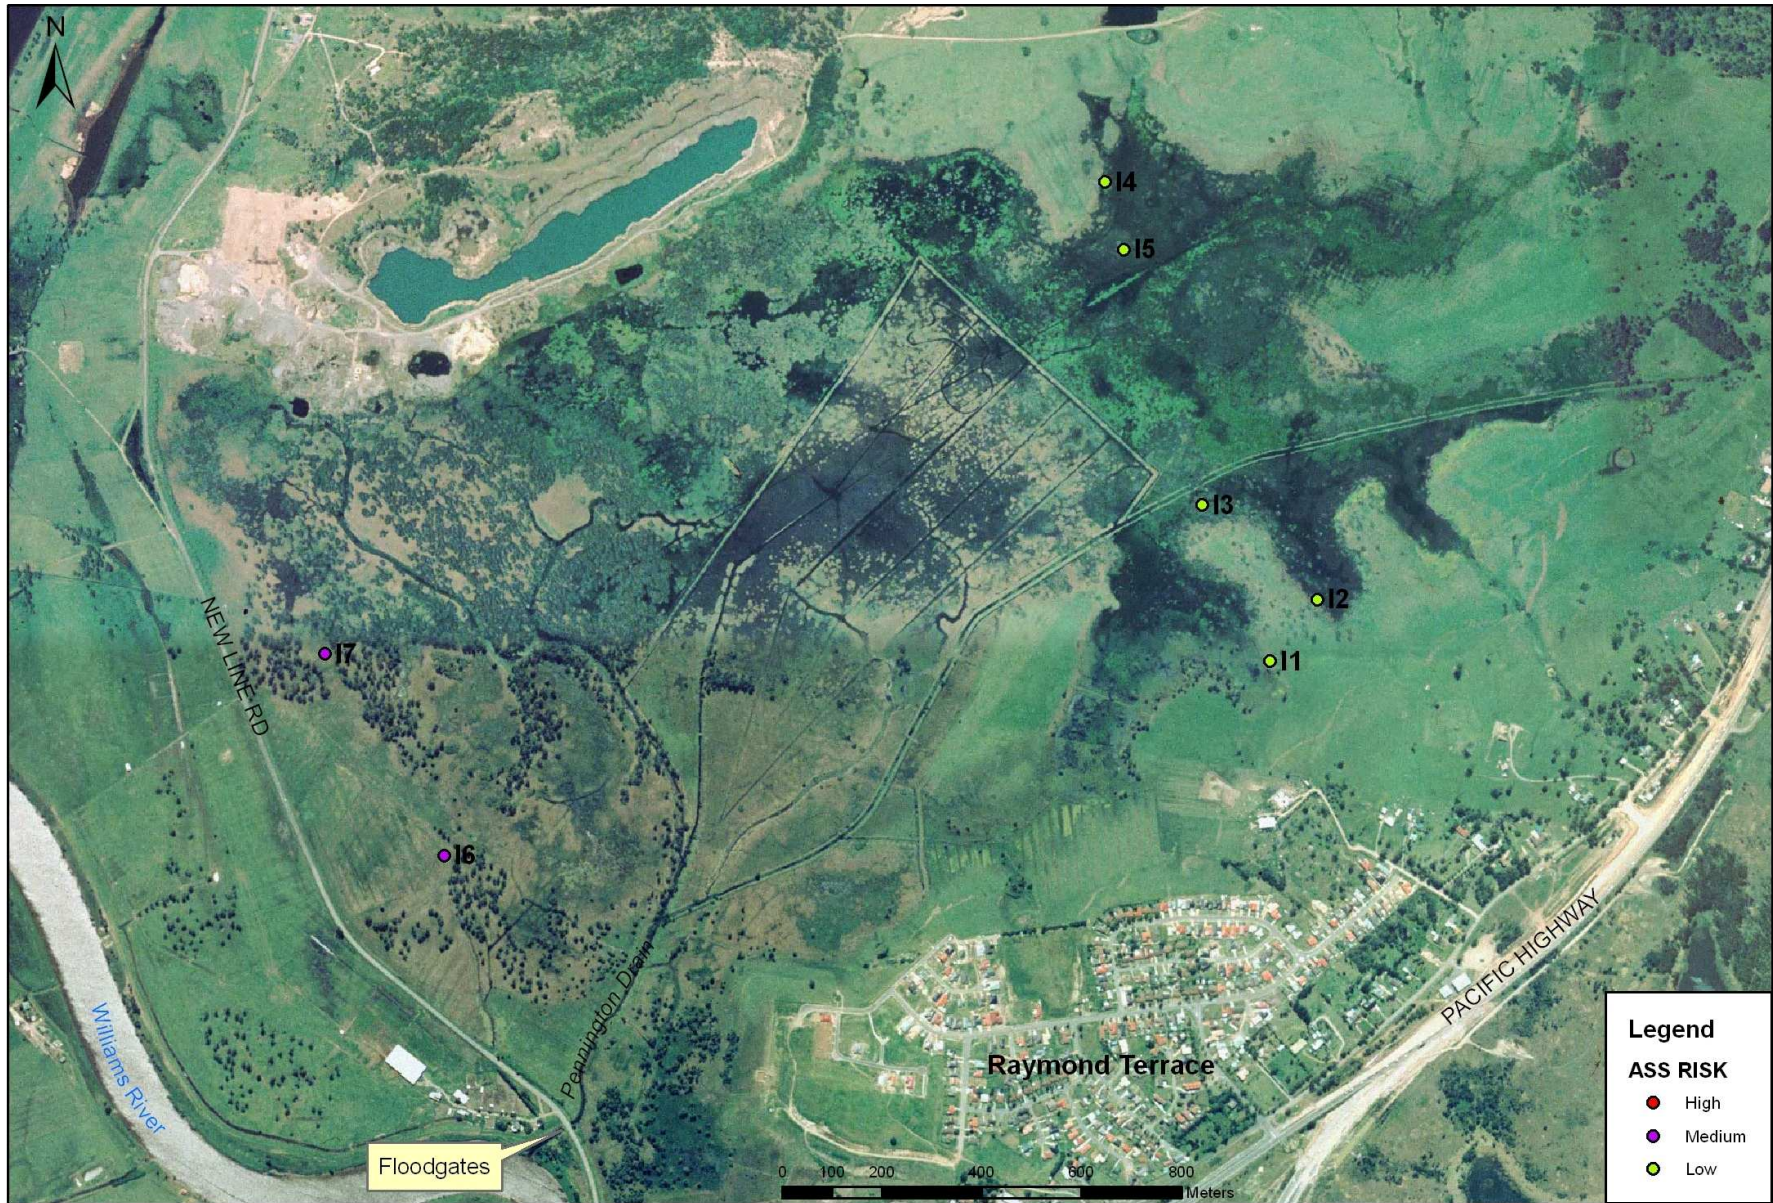
Figure 17: Irrawang Swamp Soil Core Sites

No sulfidic horizon was detected in the central area of Irrawang Swamp (site I1 - I5, table 5), although the dense clay subsoil limited the penetration of the sampling gear to a maximum depth of 1.3m (at site I5). The moisture content in the subsoil peaked just below the boundary with the topsoil and the profile becomes harder and drier at increasing depths. Profile features

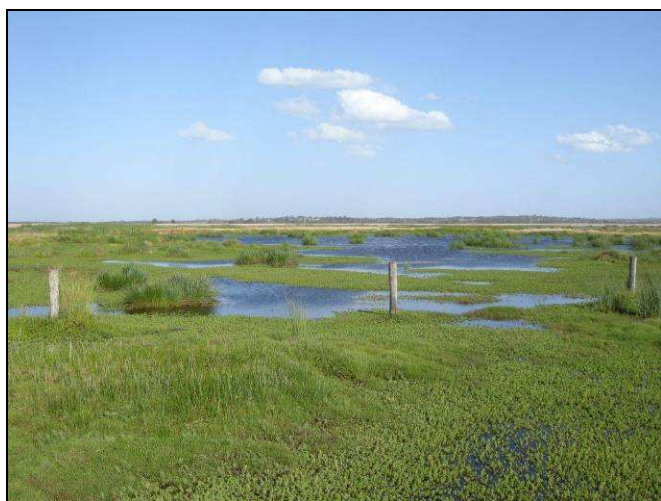
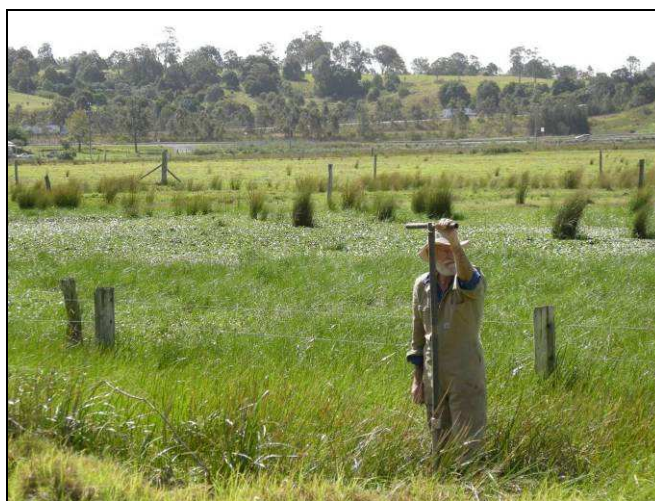
The swamp receives large volumes of surface runoff from the surrounding catchment, especially as urban stormwater. Surface drainage is poor and the soils are dominated by dense clays making them low in permeability. The old drains are clogged with accumulated sediment and freshwater swamp vegetation. As a result water ponds extensively for weeks after major rain events (figures 18 and 19). Grazing is still the predominant land use north-west of the abandoned railway, utilising grasses like water couch that tolerate frequent waterlogging. Much of this area is up to 0.5 m below sea level. It should be noted that sites H1-H6 were sampled in DPI (2008), refer to previous report for results.

Figure 18: surface water ponds in Hexham Swamp. Figure 19: Waterlogged drainage lines in the west.

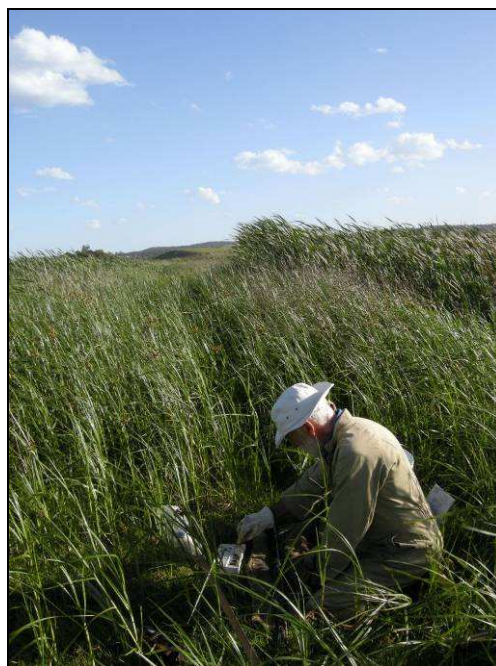
East of the old railway line are extensive beds of reeds and rushes (e.g. *Phragmites* – figure 17), and reduced grazing pressure since the gazettal of Hunter Wetlands National Park, which incorporates a large portion of Hexham Swamp. Beneath the surface water ponds, conditions can readily become anaerobic as plant residues decay and consume dissolved oxygen.

Figure 20 (right): *Phragmites* dominates the swamp (site H10)

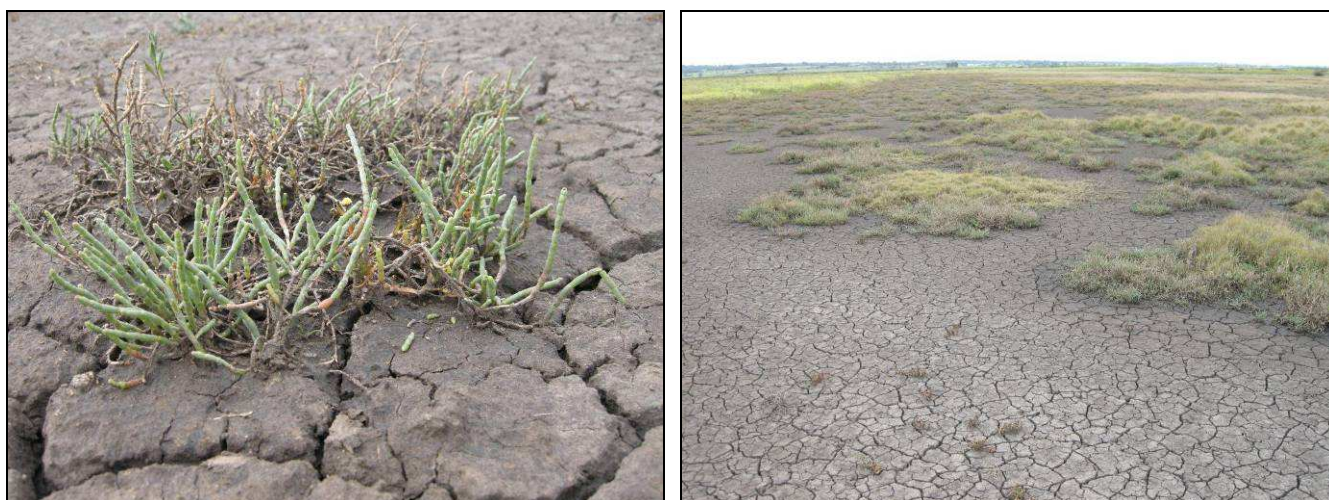
Most soils are very salty, most likely as a result of tidal action in the past, prior to the construction of the Ironbark Creek Floodgates, and probably also when the sea level was about a metre higher. Close to the southern margins of the swamp, well back from the Hunter River, are remnants of salt marsh vegetation on ground elevated slightly above the waterlogged areas (figures 21 and 22). One of the profiles here (H6) has a shelly layer at a depth of 85-90 cm. Elsewhere in the swamp the vegetation pattern suggests that tidal action currently appears to be minimal, apart from small areas in the south east near Fishery Creek where mangroves occur. The current project opening of Ironbark Creek Floodgates in stages will see tidal influence progressively reintroduced.

Figures 21 and 22: Saltmarsh and saline scalds near Rocky Knob (site H6).

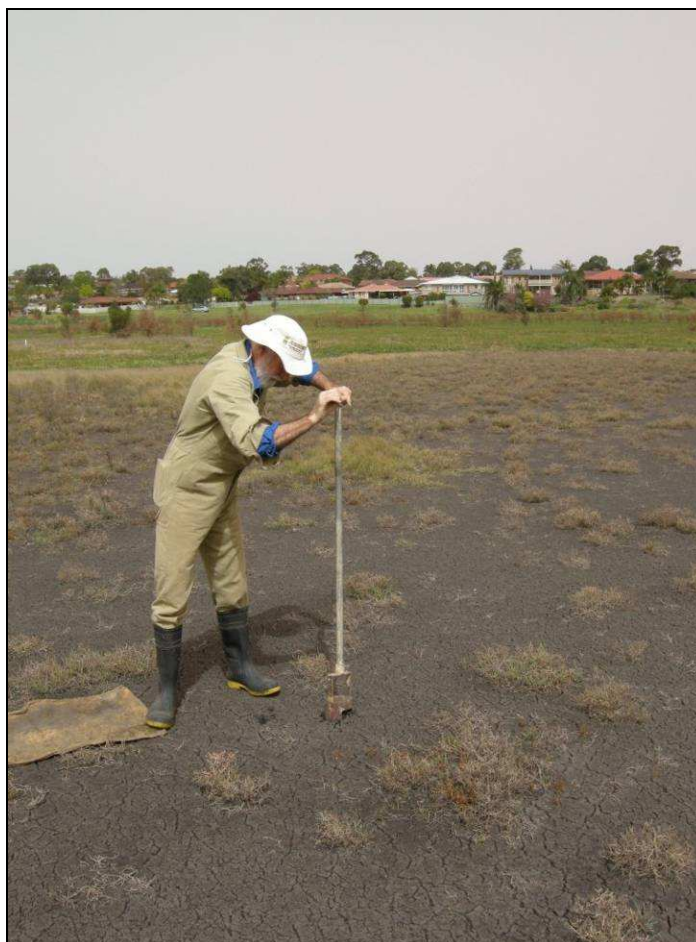
Figure 23: Ground water at Site H8 recorded the highest salinity, similar to sea water

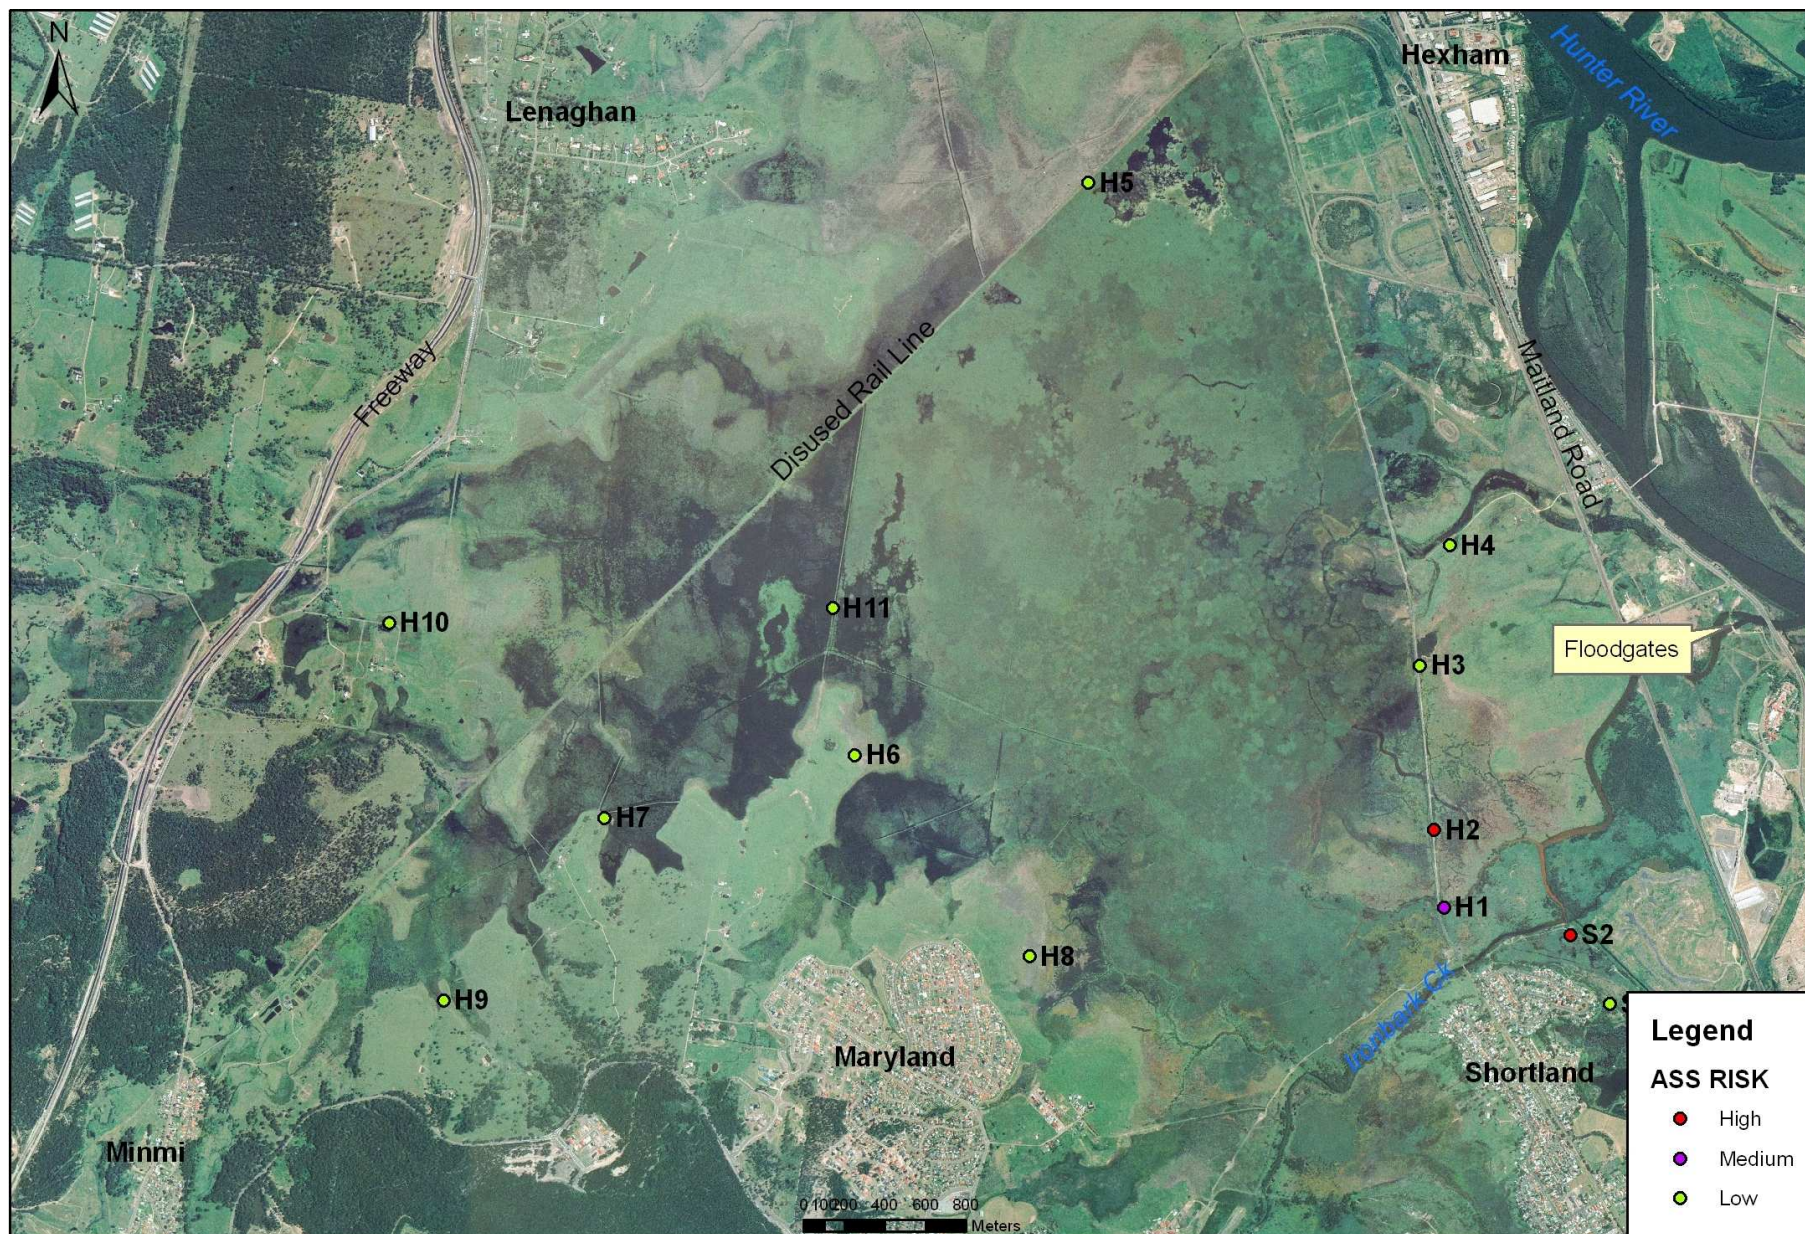
Figure 24: Hexham Swamp Soil Core Sites (including sites tested in 2008)

Six soil profiles were inspected and sampled (see figure 24), four of them located just above surface water close to the south-western edge of the swamp (H6 - H9) and two of them under 0.3-0.5 m of water further north (H10 & H11). The profiles typically have a very dark clayey topsoil about 30 cm thick (containing 1.7-7.6% organic matter) overlying a dense grey clay subsoil with occasional yellow brown mottles. The maximum depth of inspection was 1.85m. No sulfidic material was found in the subsoil, despite field testing at 10 cm intervals down the profile (see table 8). In the laboratory, only five of the 27 samples tested for reduced inorganic sulfur (RIS) contained more than the detection limit of 0.01%. The maximum level found was only 0.09% at the surface (0-10 cm) at H9. The only subsurface sample of the five cores taken (a dark grey clay from H11, 20-40 cm depth) had 0.06% RIS, which is below the regulatory remediation limit (0.1%). Graphs of soil chemical properties are provided in Appendix C.
