# Assessment of hydraulic conductivity in coastal floodplain acid sulfate soils on the north coast of NSW

REPORT PREPARED FOR THE SIX NORTH COAST COUNCILS OF NSW, MARCH 2009

# Assessment of hydraulic conductivity in coastal floodplain acid sulfate soils on the North Coast of NSW

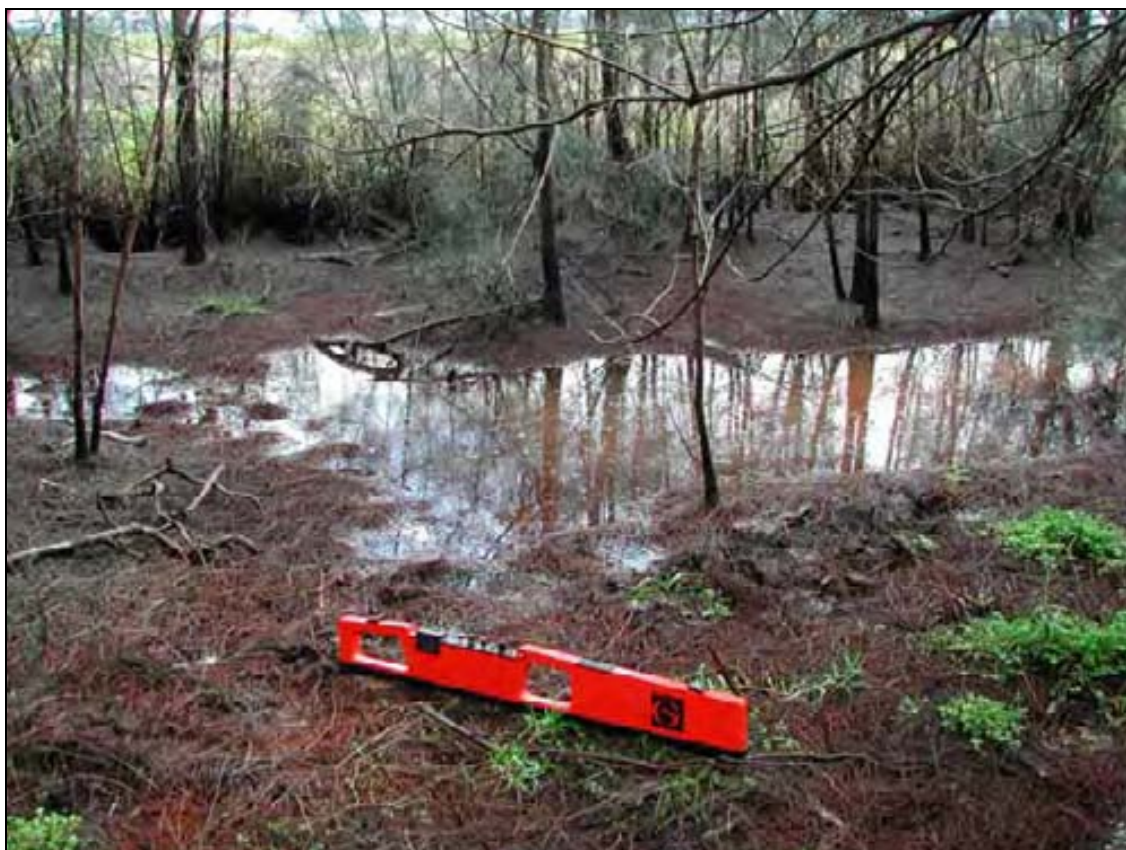
**Figure 7. EM38 at Farlows on the Clarence.**

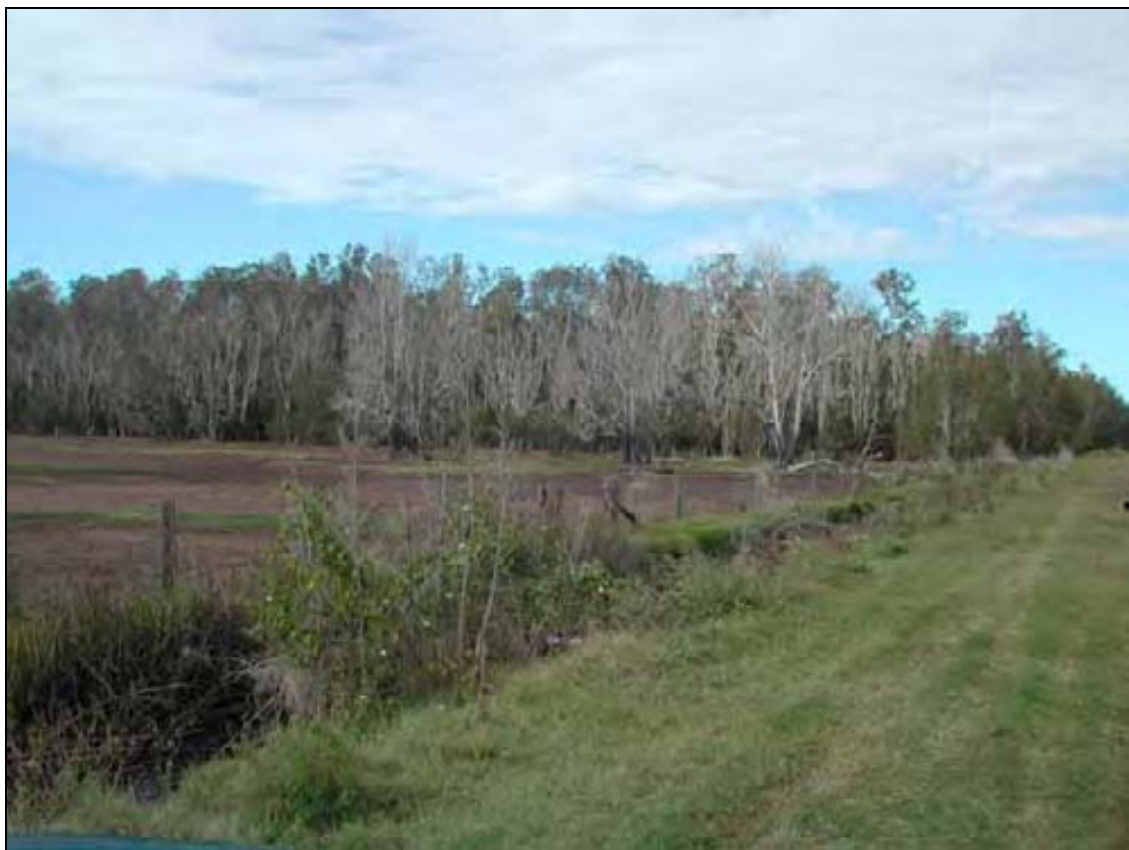
**Figure 59. Clarence site, effect of marine salt intrusion on Melaleuca forest.**

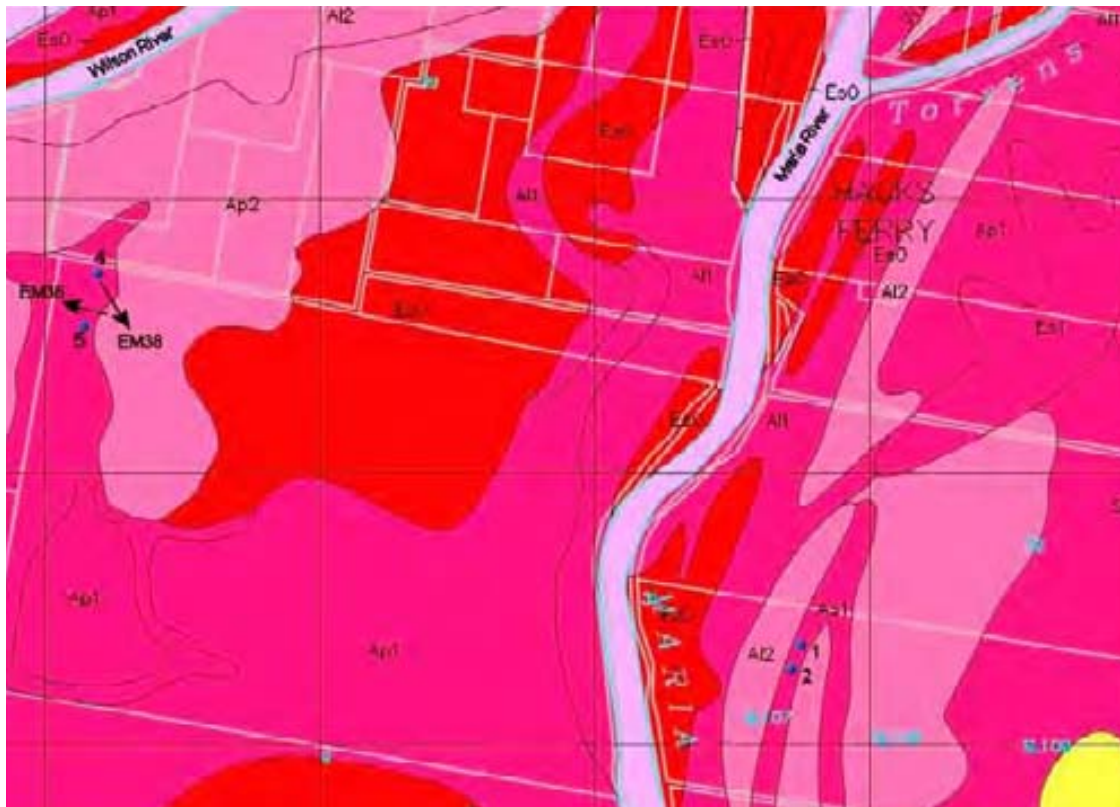
**Figure 74. Hacks ferry  $K_{sat}$  pits.**

Pits 1 and 2 located in ti-tree plantation and pits 4 and 5 in low swamp area.

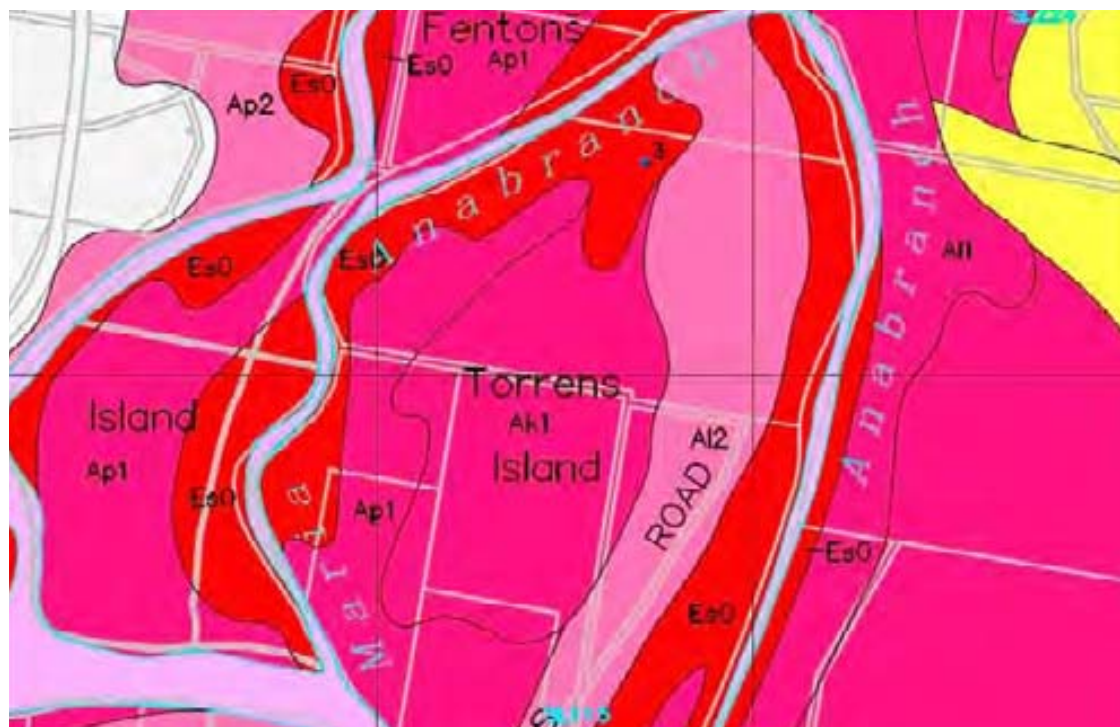
**Figure 75. One  $K_{sat}$  pit in a previous scald area at Torrens Island.**

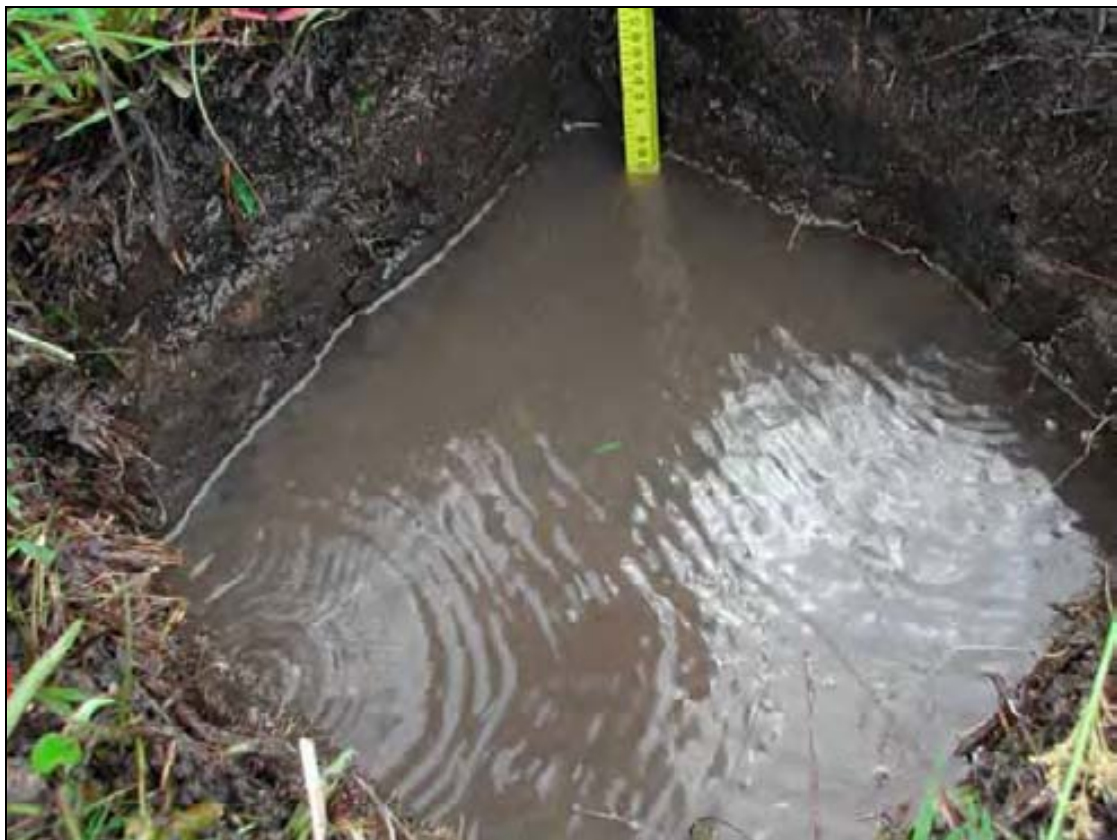
**Figure 78. Infilling pit in the Hastings catchment.**

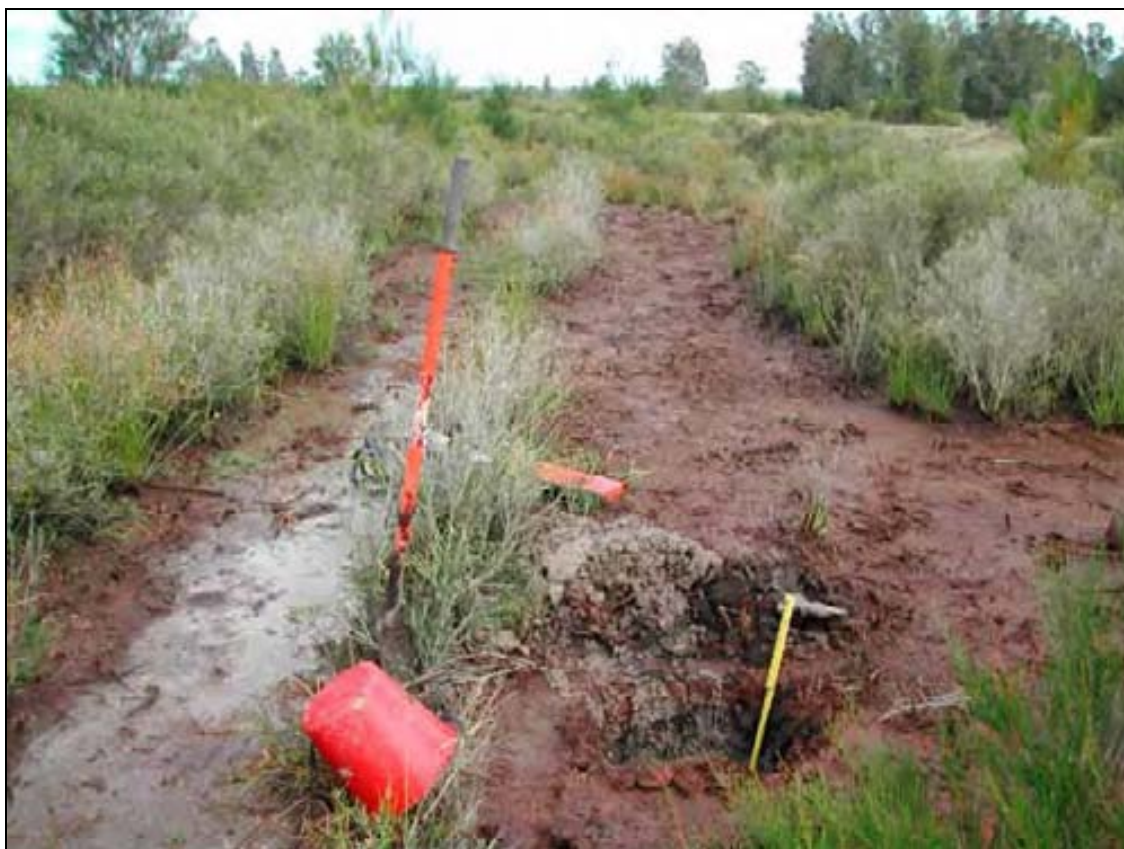
**Figure 91. Roches pit 2 in the Manning.**

Pit 2 scald area, new ti-tree regrowth area. Topsoil Fe staining on surface Peat black charcoal topsoil to light grey to darker medium clay with bright yellow jarosite paste at depth. Few reddish mottling. Common, fine to medium macropores, both vertical and horizontal.
