# **REDUCING THE IMPACT OF WEIRS ON AQUATIC HABITAT**

## **NSW DETAILED WEIR REVIEW**

#### **BORDER RIVERS/GWYDIR CMA REGION**

## 5. Border Rivers/Gwydir CMA - Detailed Weir Review Sites

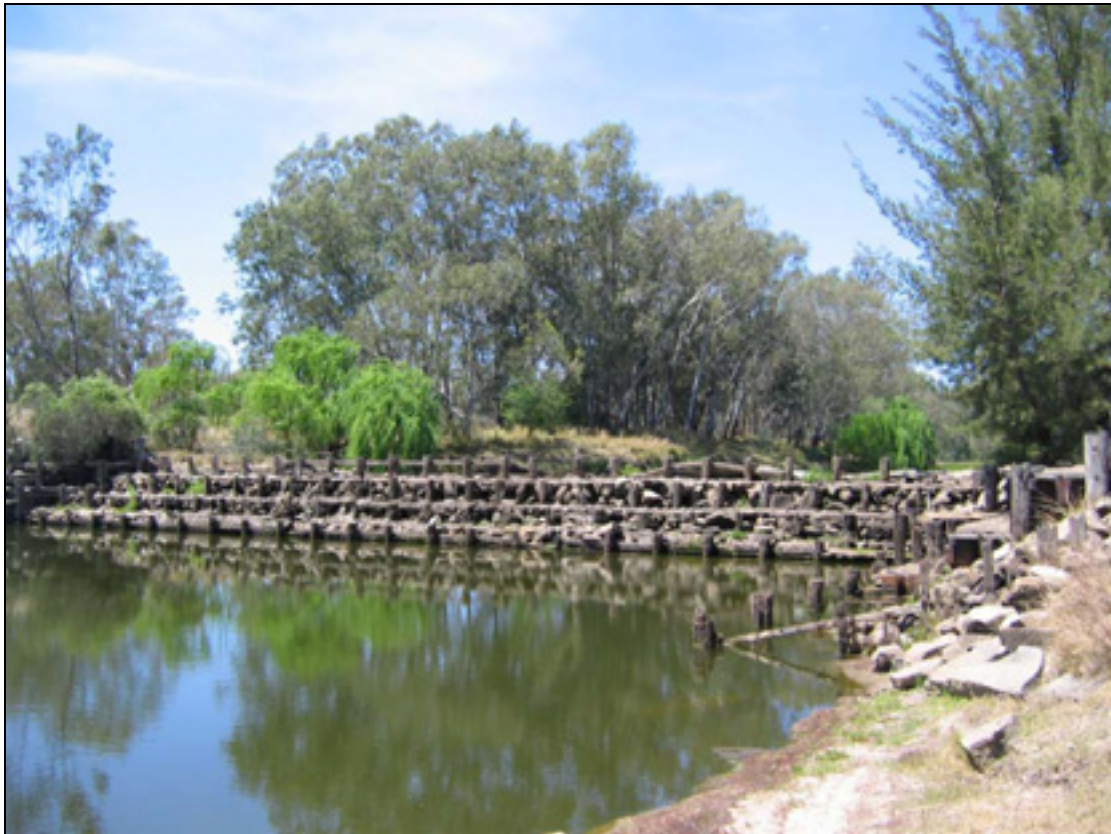
**Figure 1.** Cunningham Weir, Dumaresq River view from the left bank (0 ML/day).

- Instream habitat along the Dumaresq River is considered in medium to good condition;
- Approximately 59km of unimpeded fish habitat is available upstream of the structure;
- The low number of significant barriers to fish passage on the Dumaresq River; and
- The weir is no longer used for water retention and distribution purposes and is in severe disrepair.

The structure is frequently “topped over” by regulated flow releases from Glenlyon Dam and during flood events; however, the water levels are not sufficient for fish passage requirements. It is recommended fish passage options be further investigated at this site.

The weir in its present condition has a limited life span and could potentially fail and wash away in a large flood event. Therefore, partial removal of the structure would also require complete refurbishment of the weir to a working capacity. This option would involve removal of the upper step of the timber crib, thus reducing the full supply level to approximately EL 252.2 metres. A smaller weir pool than at present would result, thus water pumps associated to the weir pool would require modification. The large volumes of silt behind the structure would also need to be addressed to ensure silt was not released into the downstream environment, with partial or total removal of the silt an option. Refurbishment and partial removal option would also need to incorporate a fishway (see Option 4 below).

A vertical-slot fishway is the most effective design for barriers up to 6 metres high, passing large numbers of fish of all species and sizes, and would therefore be the most suitable type for this site. Refurbishment of the structure would be required, due to the limited life-span of the weir in its current condition. The left hand side of the structure is the preferred location for the fishway. The crest of the weir on this side would need to be slightly lowered to produce an attractant flow to the entrance of the fishway. This slight lowering would have marginal affects on the water level within the weir pool. Additionally, the entrance to the fishway would be located near the base of the weir (reverse leg) to attract migrating fish. Cell dimensions of 3 metres long by 2 metres wide, with slot width of 300mm are recommended for vertical-slot fishways in the Murray-Darling Basin and associated inland rivers. Maintenance of the fishway would need to be incorporated into maintenance works (e.g. debris removal) of the weir. The design would need to comply with NSW DPI policy and guidelines to ensure fish passage occurred during 95% of flows.

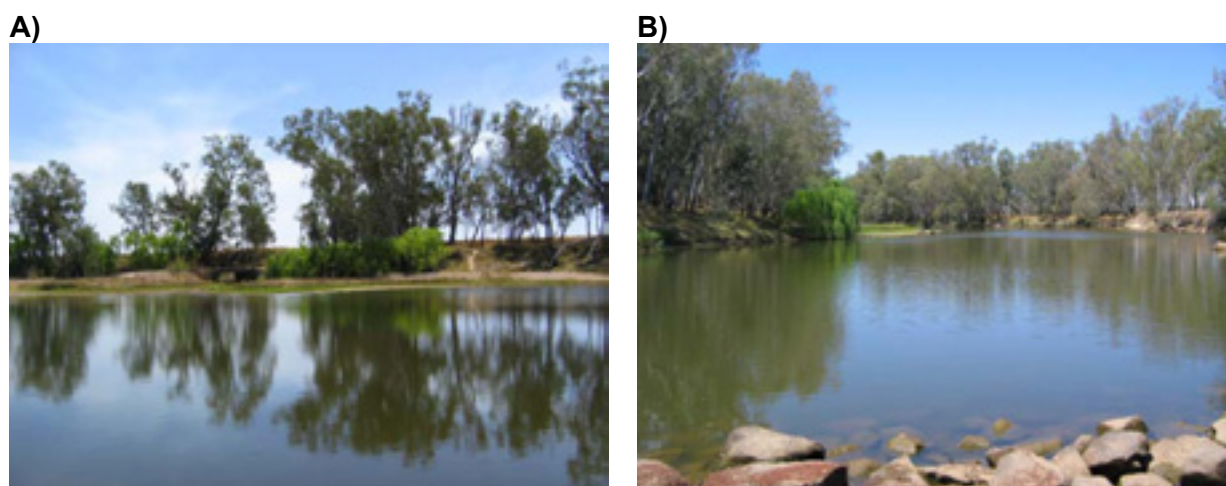
The riparian areas adjacent to the weir are moderately vegetated with blue gums (*Eucalyptus tereticornis*), river she-oak (*Casuarina cunninghamiana*), and weeping bottlebrush (*Callistemon viminalis*). Bankside vegetation, in association with the rock, clay and sandstone composition of the soil proffers stabilisation to the banks adjacent to, upstream and downstream of the structure, aiding in erosion prevention. The introduced weeping willow (*Salix babylonica*), Mexican poppy (*Argemone ochroleuca*) and Noogoora burr (*Xanthium pungens*) are also present at this site. At the time of survey the weir pool was largely clear of aquatic weed; however, aquatic weeds which may be obstructive to water flow have been observed within the weir pool including; ferny azolla (*Azolla pinnata*), ribbonweed (*Vallisneria gigantea*) and *Myriophyllum* sp. The riparian area of the weir pool is unfenced, allowing stock access to the river (Figure 2). This can have severe ecological impacts on the riparian area, the aquatic habitat, and aquatic biota. The river bed downstream of the structure is stable. However, a large volume of silt has accumulated immediately behind the weir to within approximately one metre of the weir crest (estimated to between 50,000 and 120,000 cubic metres). In consequence, a change of bed level from EL 249.2 to EL 252, approximately 2.8 metres is present from the downstream to upstream side of the structure.

**Figure 2.** Dumaresq River A) upstream and B) downstream of Cunningham Weir.

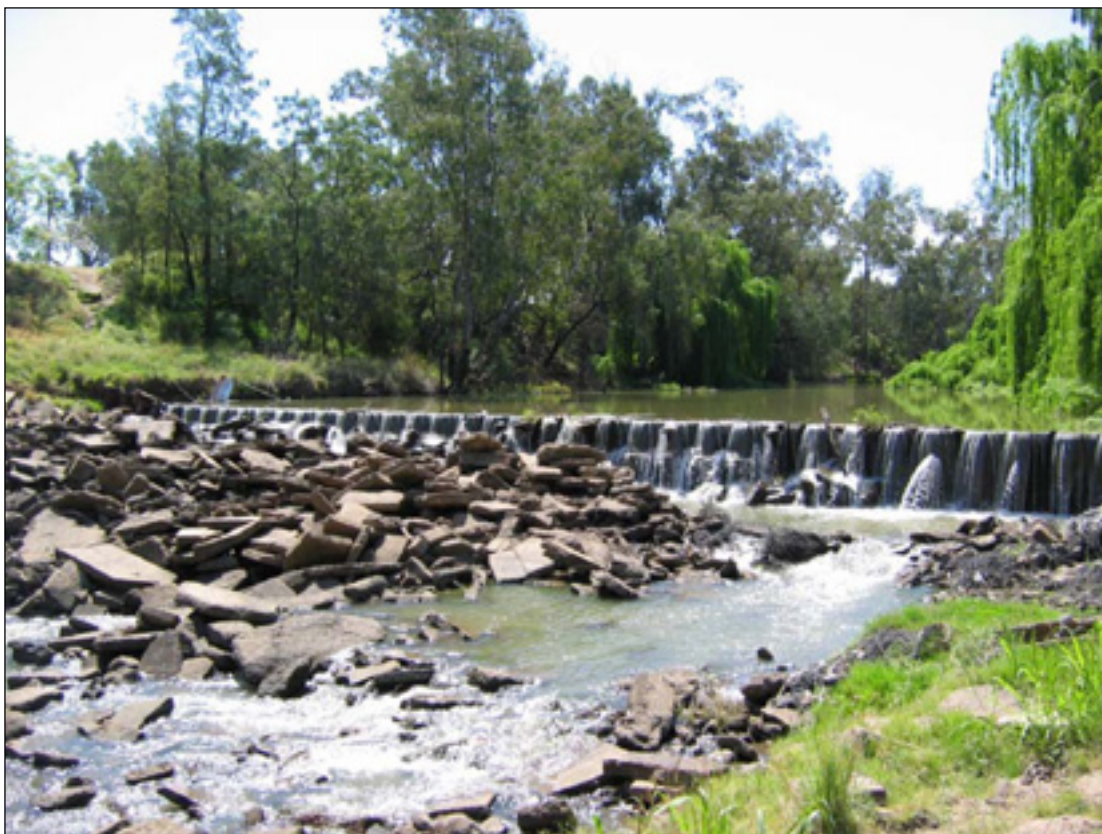
Figure 1. Moree Weir, Mehi River view from left bank.

Moree Weir (Figure 1) is located within crown land reserved for public recreation. The weir, which is accessed through Kirkby or Jellicoe Park's in Moree, sits on the mainstem Mehi River, located in the Moree subcatchment (which encompasses 4.74% of the Gwydir system) in the Lower Barwon catchment area. The weir is a fixed crest sheet piling structure that measures 3.9 metres high by 28 metres long. A centrally placed, vertical slide gate for low flow conditions is installed (however, there is no record of this being used). Large quantities of concrete are present on the downstream, right bank side of the structure, seemingly placed by Council in an attempt to stabilise the structure and the rock filled mattresses (gabions), most of which have been degraded and washed away by flood events. Moree Weir pools water over approximately 2km, at depths varying from 1 to 2 metres, and has a capacity of approximately 350ML. Fish passage only occurs at this structure when drown-out takes place during large flood events (1-3 times a year). For the majority of the time the weir represents a barrier to fish passage due to a stepped “*waterfall effect*” over the crest of the structure, producing a large headloss of approximately 150cm.

Fish are only able to pass this weir during large flood events, when the structure completely drowns out. It is recommended fish passage options be further investigated at this site and that any remediation project also incorporates:

This option would involve a reduction in the height of the weir to approximately 2 metres. Partial removal of the structure in conjunction with removal of the downstream concrete would require investigation into the stability of the structure. If unstable, the weir could potentially fail and wash away in a large flood event. A smaller weir pool than at present would result; however some water would be retained for aesthetic purposes and recreational use by the community. The large volumes of silt behind the structure would also need to be addressed, to ensure the silt was not released into the downstream environment, with partial or total removal of the silt an option (with total removal being the preferred option). To ensure fish passage at this site, this option would incorporate the installation of a full width or partial width rock-ramp fishway. A full width rock-ramp fishway would be the most ideal type; however, construction costs would be high. Therefore, a partial width, reverse leg rock-ramp located to one side of the structure, ensuring the entrance to the fishway was located near the face of the weir to attract migrating fish is also an option.

Option 1, the total removal of Moree Weir is the preferred option for remediation of fish passage to this reach in the Gwydir River system. However, the social implications of this option are fully understood. Although there are no economic benefits directly associated with the weir, it is still of great value to the local community; providing a pool for recreational and aesthetic purposes. Taking the needs of the local community into consideration in conjunction with the aim to improve fish passage at this site, Option 2 is therefore recommended. Further investigation and consultation with fishway experts and engineers would be required to ensure designs were technically sound.

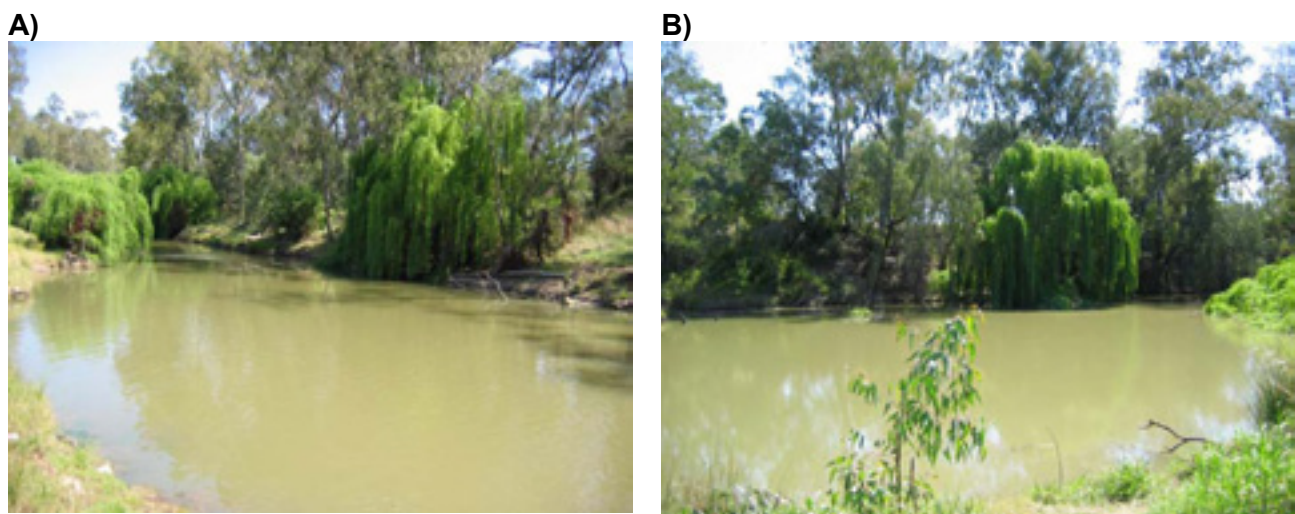
The park-land area surrounding the weir is grassed and mowed on a regular basis. The riparian areas upstream to the weir are moderately well vegetated with a combination of eucalypt species including river gums, and the introduced pest species weeping willow (*Salix babylonica*). Downstream of the weir, the vegetation cover is less extensive, with weeping willows the predominant species (Figure 2A and B). Immediately adjacent to the structure the banks are steep and extensive erosion is evident. The concrete (largely on the right hand side bank) below the weir is causing a diversion of flows and consequently, serious undercutting of the left bank. A relatively large accumulation of silt is present immediately behind the structure, resulting in a change in bed level from the upstream to downstream side of approximately one metre.

**Figure 2.** Mehi River A) upstream and B) downstream of Moree Weir.

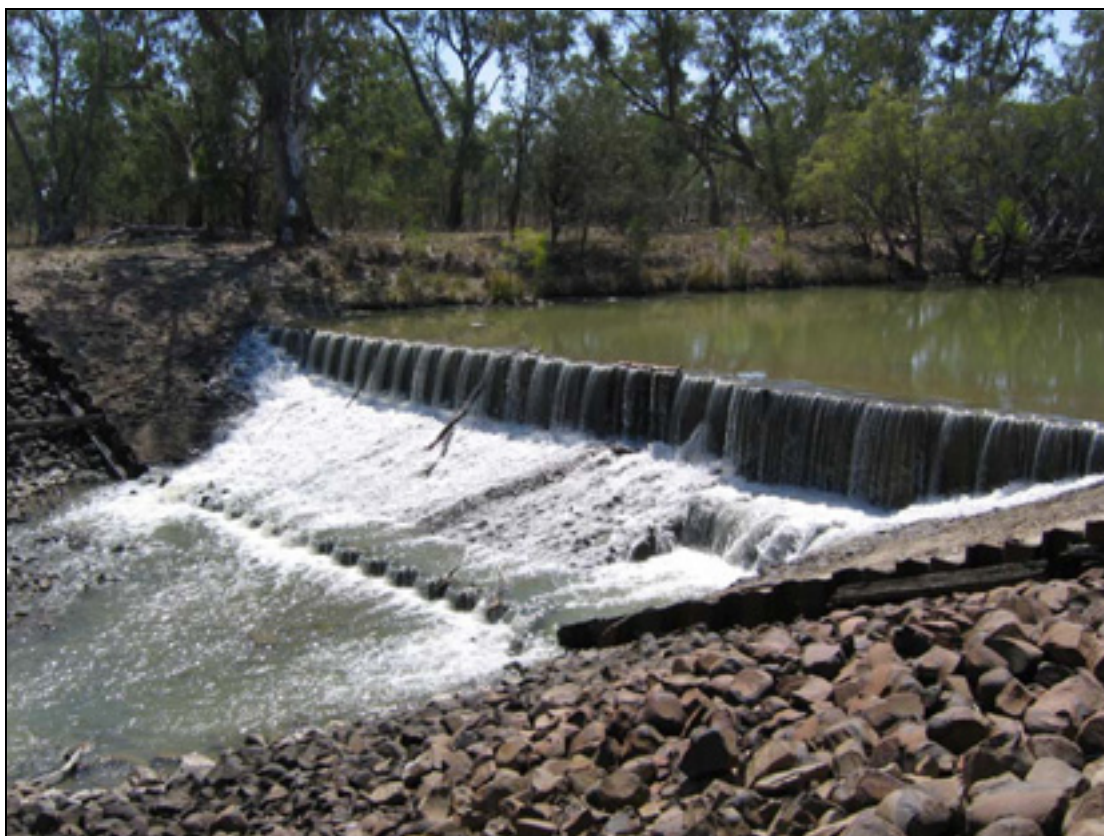
**Figure 1.** Boomi Weir, Macintyre River view from left bank (61.424ML/day)

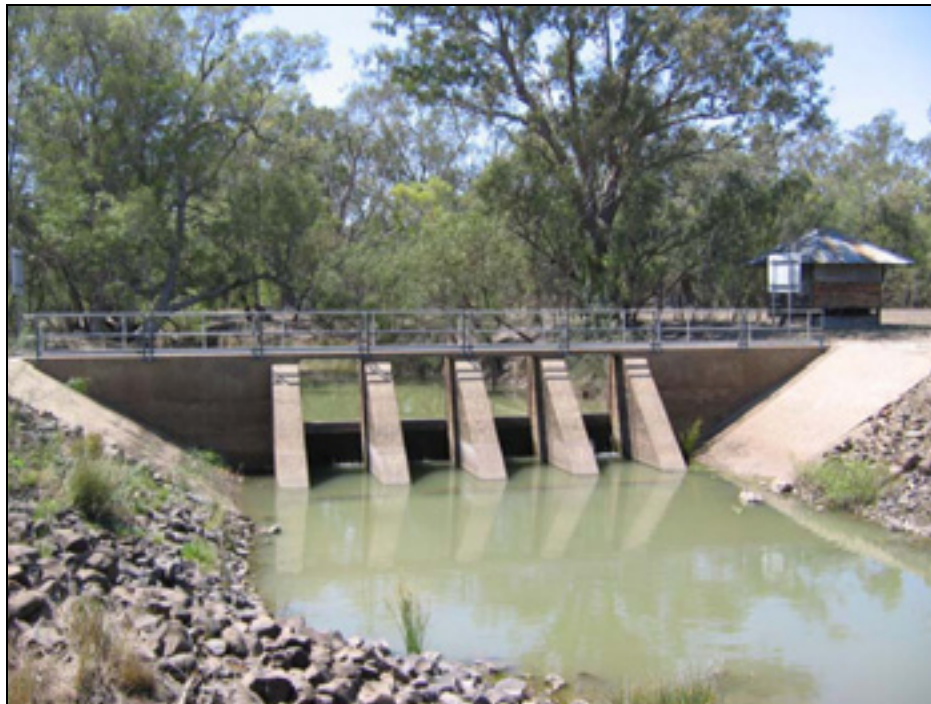
Hydrological flows for the Macintyre River referred to in this report were determined from DNR river gauge #416043, and sourced from the DNR website and staff members of SunWater. Flows within this section of the Macintyre River are dictated to by rainfall levels in the middle and upper reaches of the catchment, regulated water release from Glenlyon and Pindari Dams and re-regulated flows from Boomi Regulator. Boomi Regulator is located on the Boomi River, in close proximity to Boomi Weir, 200 metres downstream of the confluence between the Macintyre and Boomi Rivers (Figure 2).

**Figure 2.** Boomi Regulator, Boomi River.

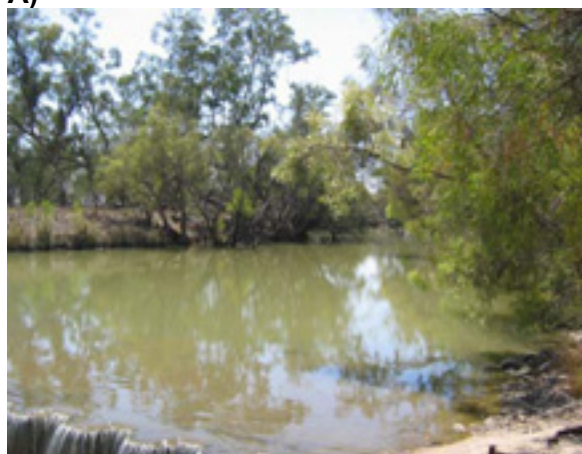
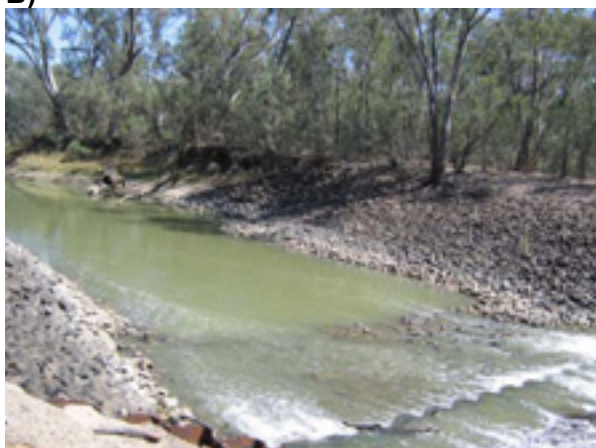
**Figure 3.** Macintyre River A) upstream and B) downstream of Boomi Weir.

The riparian areas adjacent to the weir are moderately well vegetated with a variety of pasture grasses, a mix of eucalypt species, including blue gums (*Eucalyptus tereticornis*), and ti tree bark (*Melaleuca sp.*) and casuarinas. Also present in close proximity to the weir is the parasitic mistletoe (*Amyema sp.*), upon which the ubiquitous mistletoe bird (*Dicaeum hirundinaceum*) can be observed feeding.

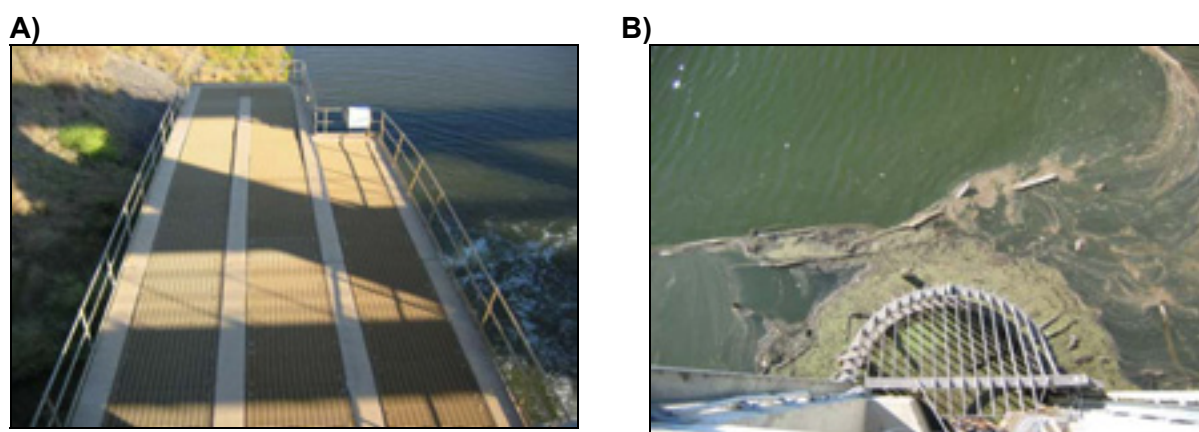
**Figure 2.** A) Vertical-slot fishway and B) debris accumulated at exit of fishway.

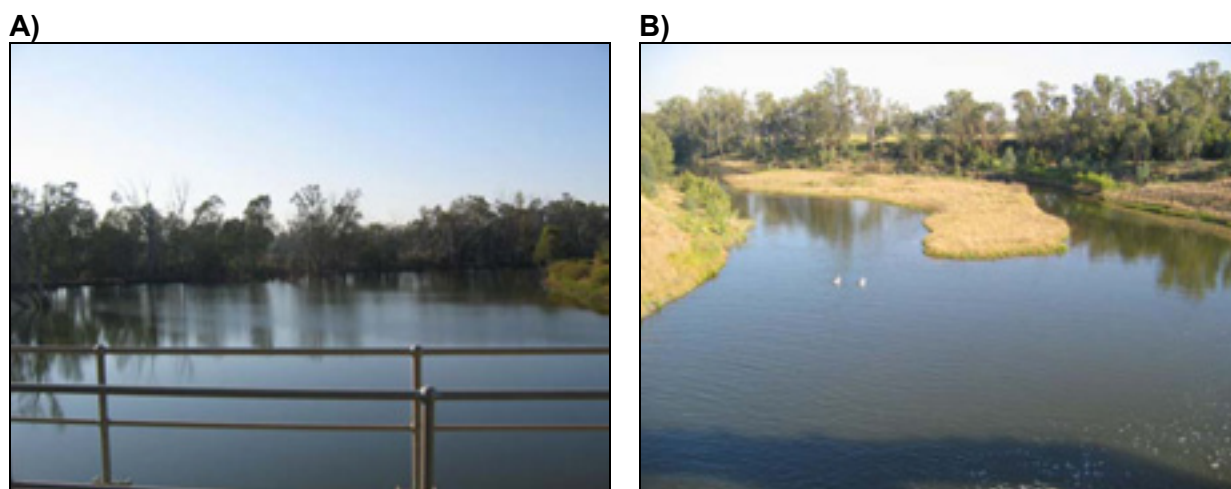
**Figure 3.** Macintyre River A) upstream and B) downstream of Boggabilla Weir.

The river banks adjacent to the weir are moderately vegetated with a variety of pasture grasses, blue gums (*Eucalyptus tereticornis*), common reeds (*Phragmites australis*) and ti trees (*Melaleuca sp.*). This vegetation cover is not as extensive as it was prior to construction of the weir. Increased bank slumping, steeper banks and decrease in vegetation cover have led to destabilisation of the riparian zone. This is particularly evident downstream of the weir (on the right bank), where the bank is severely eroded. This action is possibly the consequence of the formation of a sand island in the centre of the main channel (Figure 3B) that has resulted from changes in hydrology following weir construction. In addition, dieback of melaleucas and river gums is taking place along the back fringing edge of the weir pool, due to their prolonged inundation since the weirs' construction.

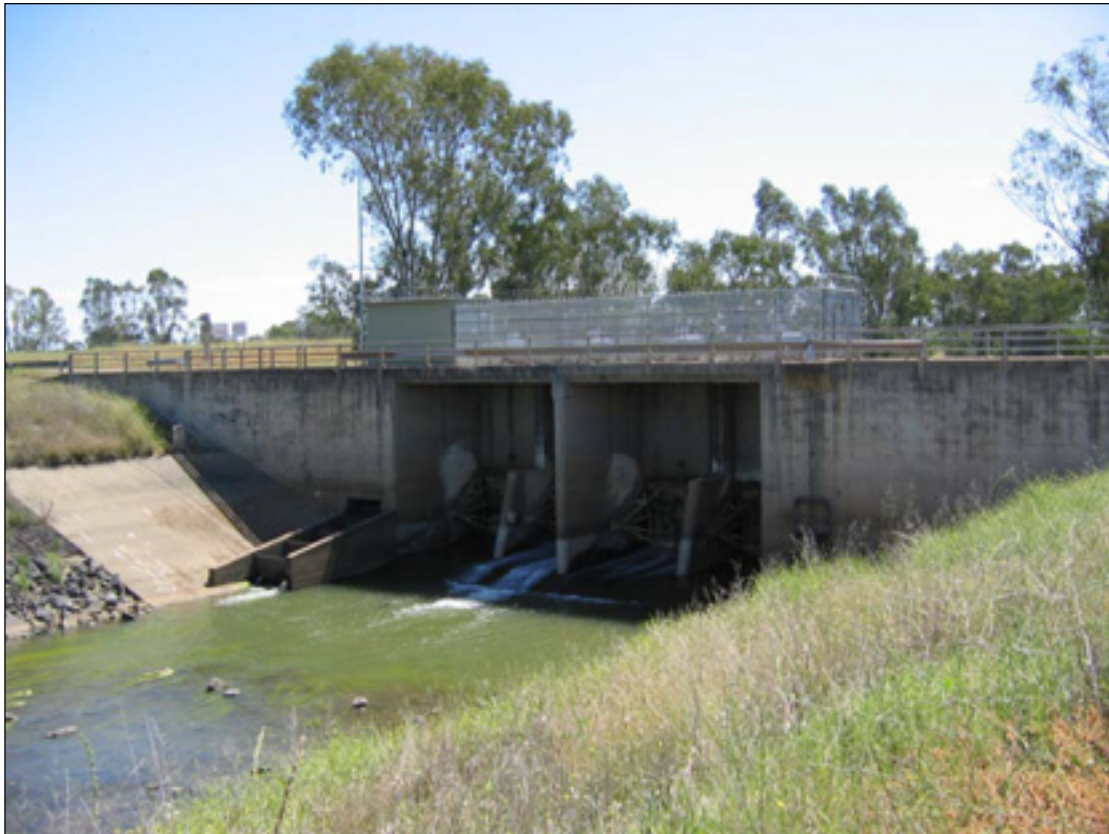
**Figure 1.** Tareelaroi Regulator, Mehi River view of weir from left bank (29.751ML/day).

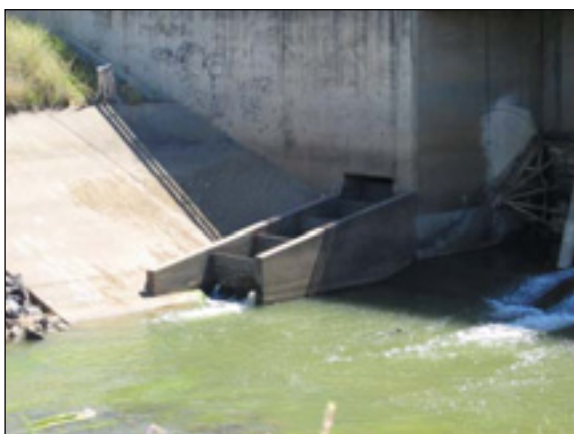
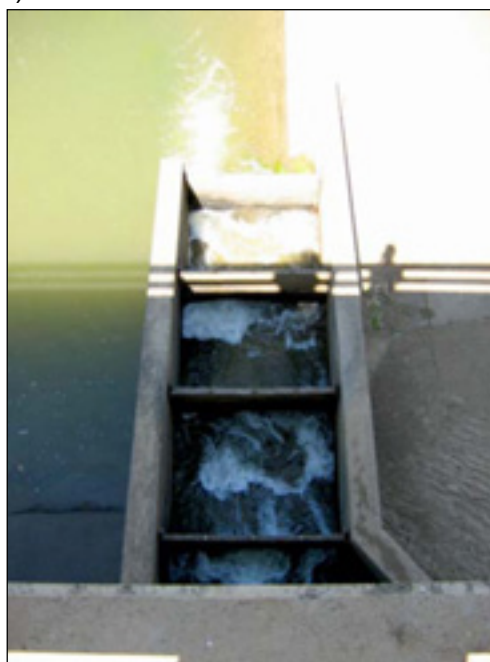
**Figure 2.** A) and B): submerged-orifice fishway, Tareelaroi Regulator.

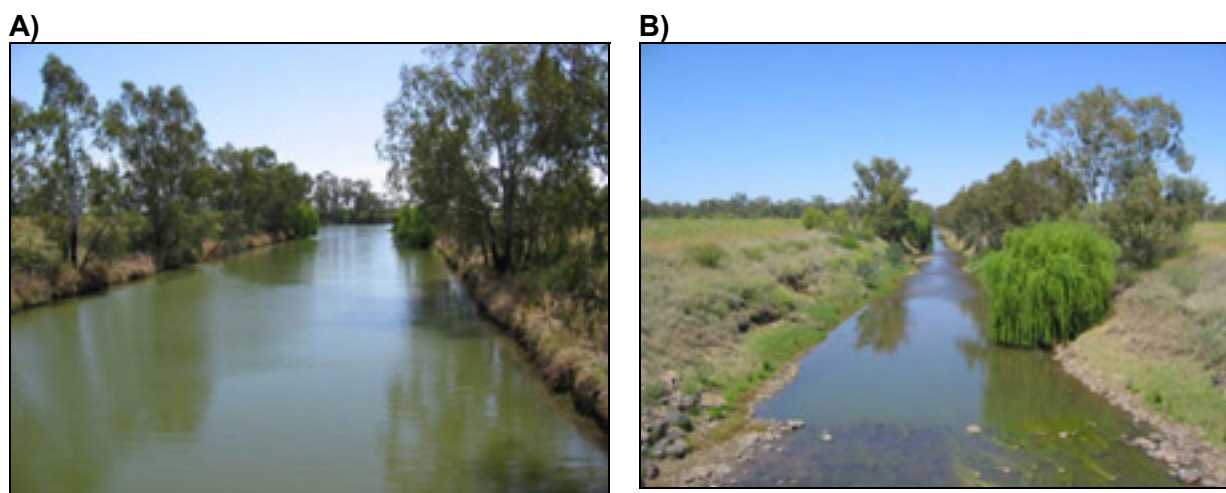
**Figure 3.** Mehi River A) upstream and B) downstream of the Tareelaroi Regulator.

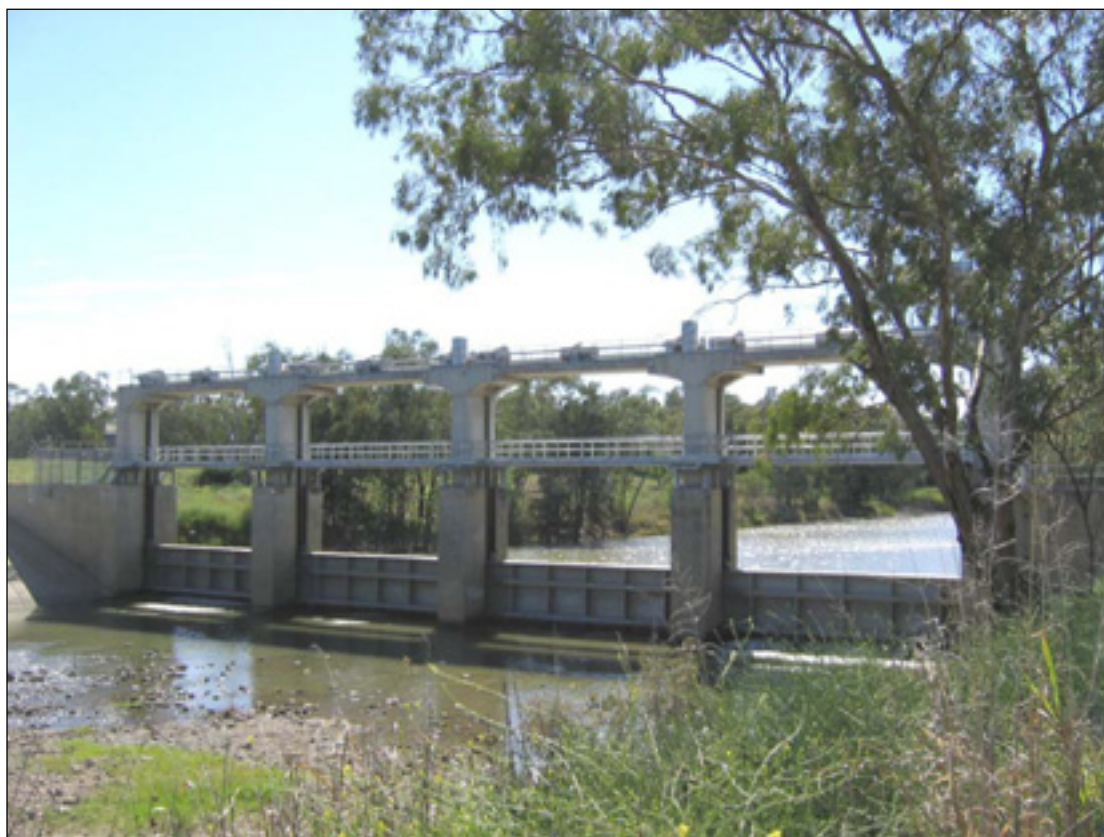
**Figure 1.** Boolooroo Weir, Mehi River view of weir is from the left bank (12.10.05, 66.593ML/day diverted into Carole Creek).

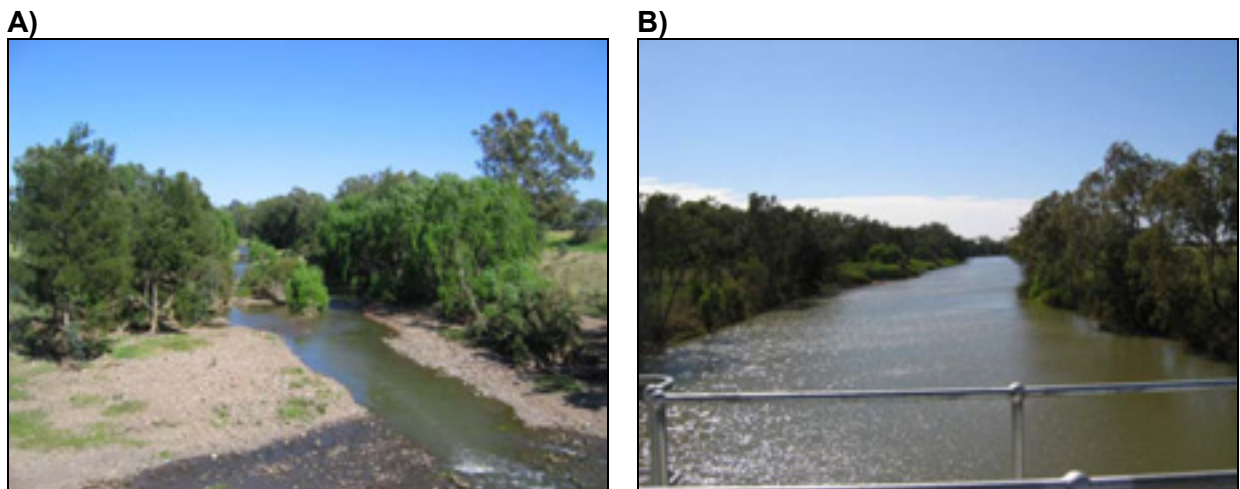
**Figure 2.** Mehi River A) upstream and B) downstream of Boolooroo Weir.

The river banks, up and downstream of the weir are well vegetated with a combination of pasture grasses, casuarinas and eucalypts (Figure 2). This vegetation coverage provides vital stabilising qualities to the riparian zone, aiding in erosion prevention. However, weeping willows (*Salix babylonica*) are also present, and the weir pool and downstream channel are unfenced.

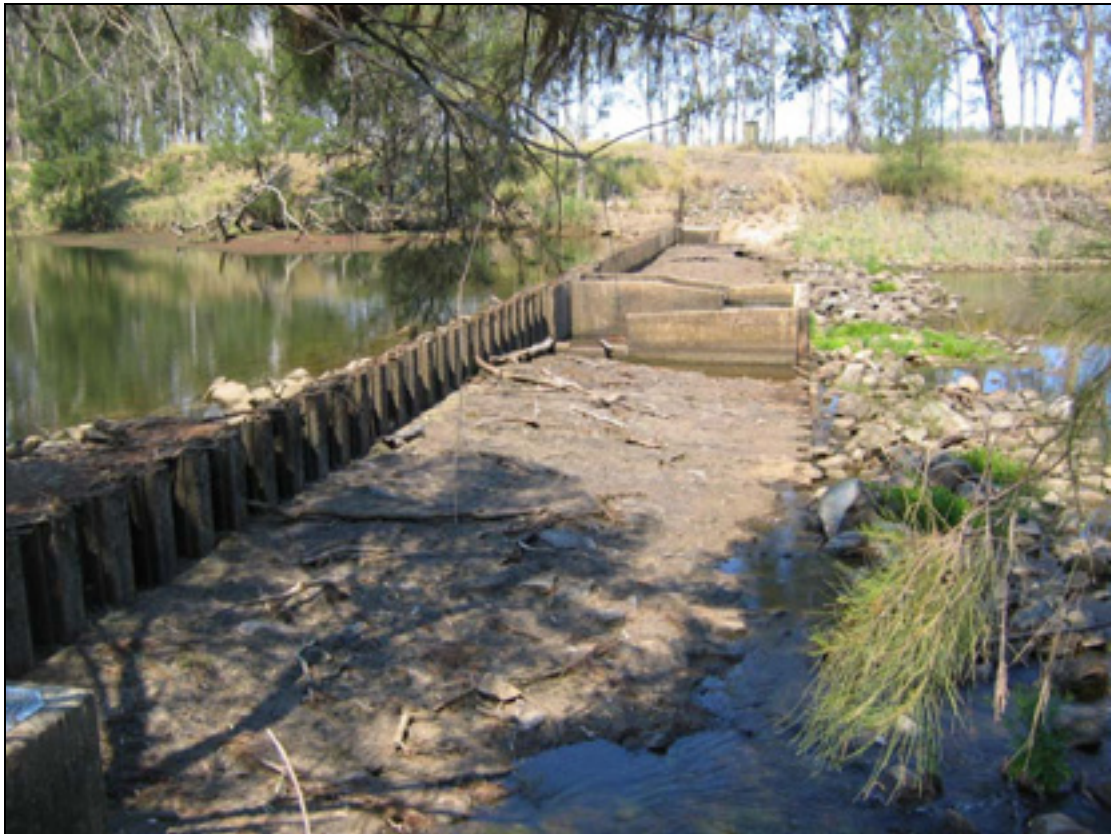
**Figure 1.** Glenarbon Weir, Dumaresq Riverview from the right bank (0.0ML/day).

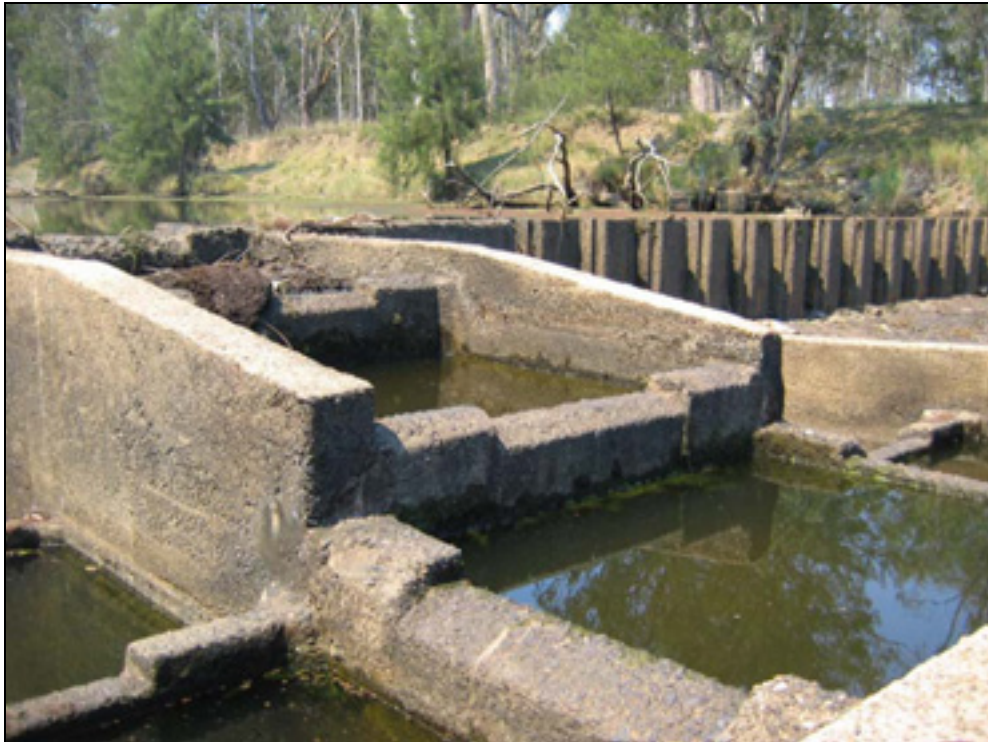
**Figure 2.** Pool-type fishway, Glenarbon Weir.

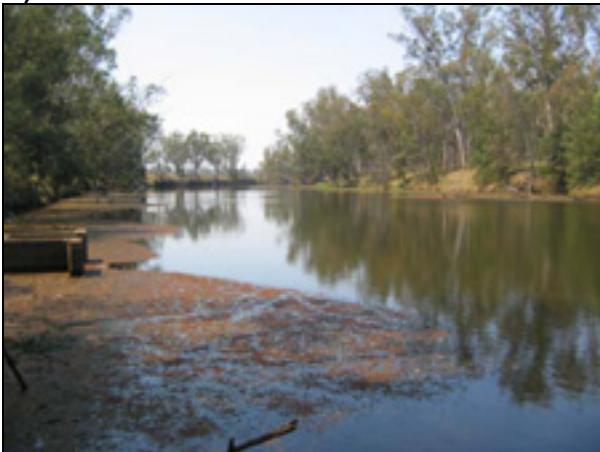
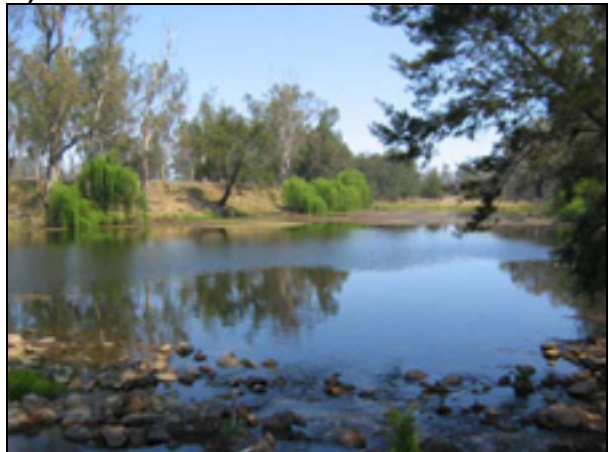
**Figure 3.** Dumaresq River A) upstream and B) downstream of Glenarbon Weir.

The riparian areas adjacent to the weir are moderately vegetated with a variety of pasture grasses, blue gums (*Eucalyptus tereticornis*), common reeds (*Phragmites australis*) and casuarinas. This vegetation proffers stabilisation to the banks adjacent to, upstream and downstream of the structure, aiding in erosion prevention. The introduced weeping willow (*Salix babylonica*) is also present upstream and below the structure (Figure 3). Nuisance aquatic weeds are a recurring issue within the weir pool. At the time of study a large mass of ferny azolla (*Azolla pinnata*) and hornwort (*Ceratophyllum demersum*) was observed immediately upstream up the structure (as shown in Figure 3), colonising approximately 20% of the visible weir pool.
