# Case study: Improving riparian vegetation and biodiversity in a public space

## Somerset Park, Orange, Orange City Council

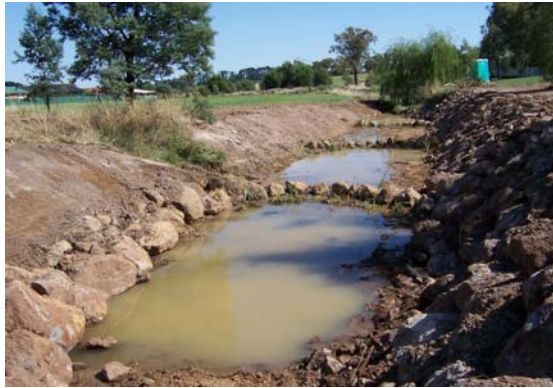
*A 'chain of ponds' was created in the creek to slow water and aid sediment deposition.*

- Removal of crack willows via best practice methods, Work for the Dole workers were engaged for willow poisoning and contractors for willow removal.
- Construction of in-stream structures; a rock chute and bank protection to create a chain of ponds system. Specialised contractors were engaged to undertake earthworks and rock placement.
- Revegetation of the site for biodiversity, bank stabilisation and aesthetic purposes. The Orange community were engaged to assist Council with planting native trees and shrubs throughout the park in biodiversity islands (small stands of trees and shrubs in mulched beds of up to 300 metres square).

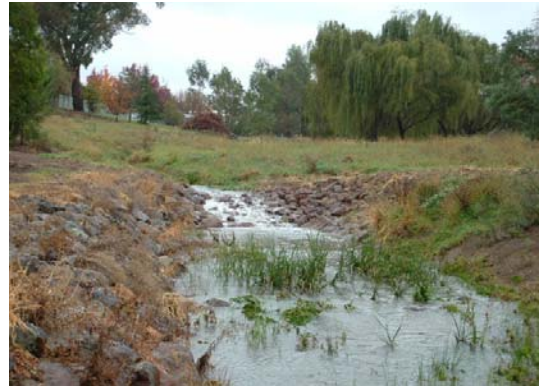
*A rock chute was also installed to prevent bed erosion.*

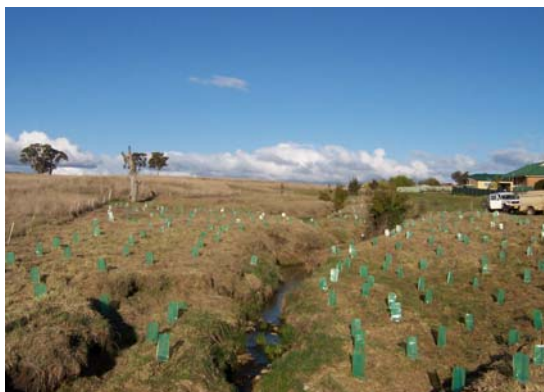
*Extensive replanting was conducted by Conservation Volunteers Australia.*

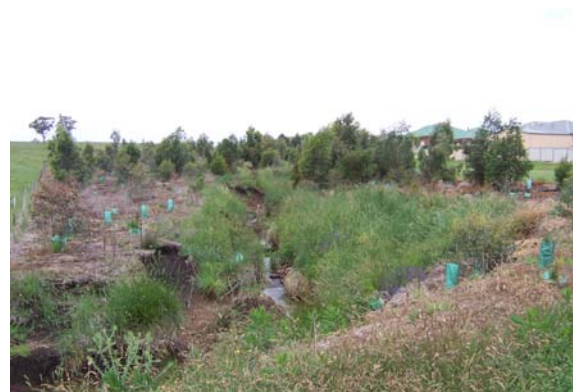
*26 months on, the revegetation and natural regeneration have been highly successful.*
